LIMITED CURRENT AND BATHYMETRIC SURVEYS AT  
THE MARINE OUTFALL IN LELU HARBOR  
AND  
RECONNAISSANCE SURVEYS OF EFFLUENT DISPOSAL  
SITES AT MALEM AND UTWE, KOSRAE

UNIVERSITY OF GUAM  
*Water and Energy Research Institute  
of the  
Western Pacific*

Technical Report No. 55

Project Completion Report  
for  
Trust Territory of the Pacific Islands  
Contract No. 410046

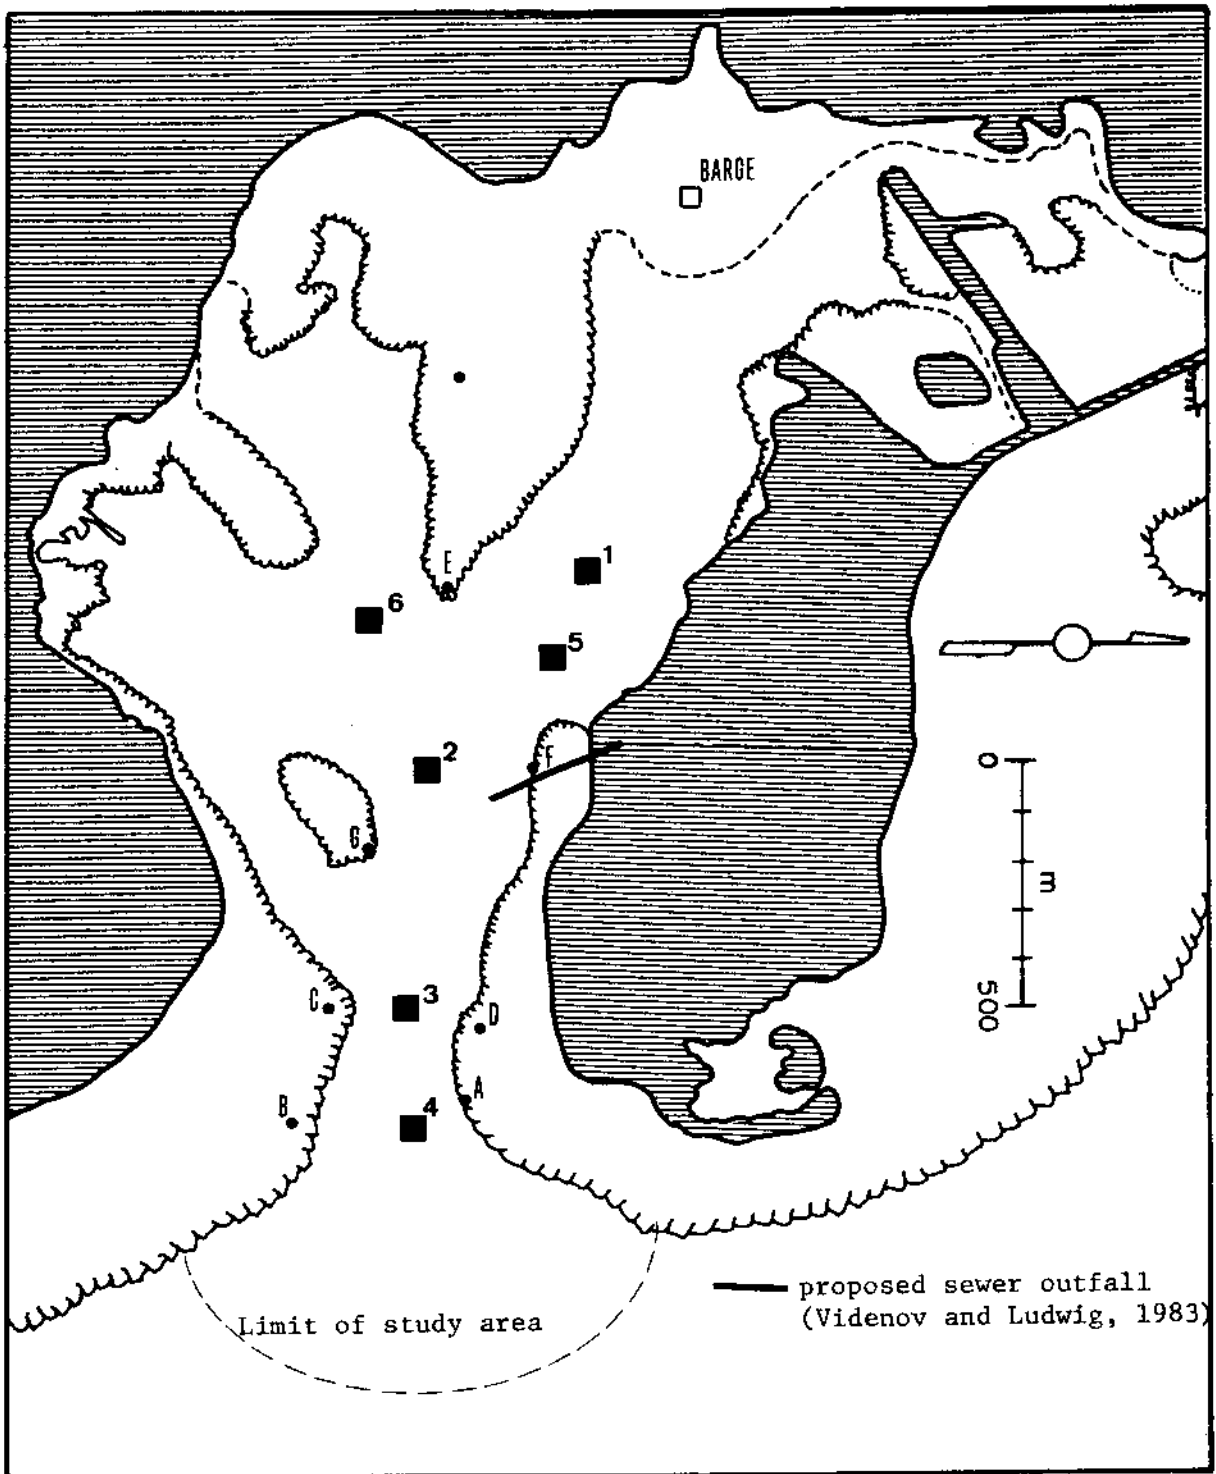
Figure 2. Lelu Harbor with drogue release areas (numbered squares), harbor bouys (letters A to G) and limit of current and bathymetric survey.

The proposed Lelu marine outfall was designed and recommended for placement in the eastern portion of the harbor about 500m west of the entrance (Figure 2). Environmental agencies were concerned about the placement of a marine outfall in the harbor area. There were only limited data available for marine water circulation patterns in the harbor. Additionally, there were no available bathymetric surveys which defined the harbor floor topography. Since there was this notable lack of data available to characterize the anticipated effluent discharge plumes, both residents of Lelu and the local environmental health office were concerned about pollution (primarily bacteriological) of Lelu shoreline by sewage. Finally, the facilities plan did not adequately deal with plume dispersion under various tidal conditions.

Based on preliminary current flow patterns and harbor topography, a recommended area for a marine outfall in Lelu Harbor is shown in Figure 20. Placement of an effluent diffuser in this area would maximize dispersion of the plume and minimize environmental impact along the Lelu shoreline. The diffuser should be placed as close to the harbor entrance as possible, but not further seaward than D-Bouy (Figure 2).

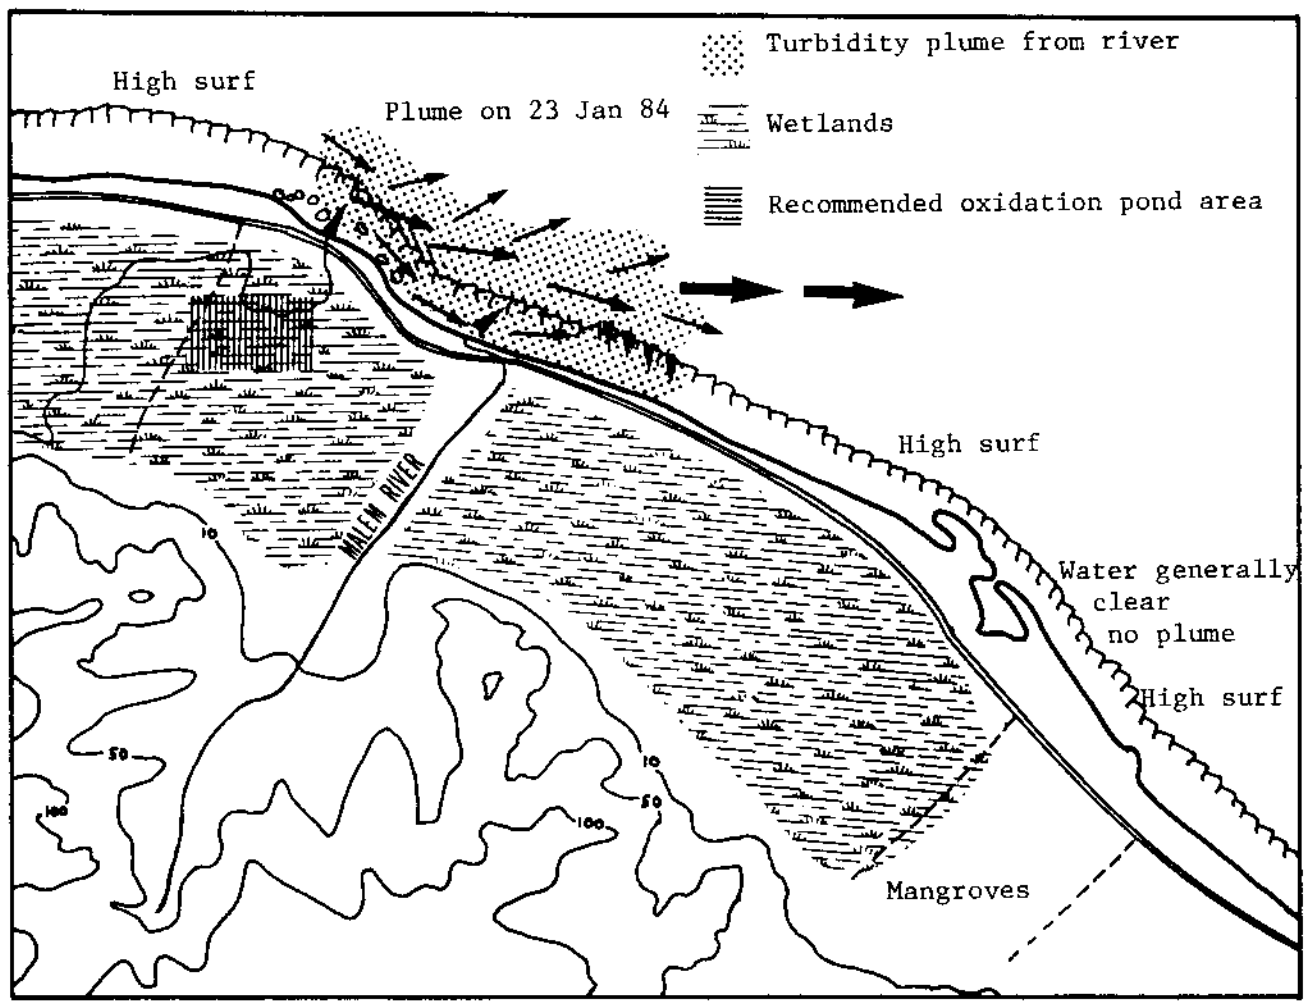
A reconnaissance level survey was made of the Malem coastline and reef-flat in January, 1984. The generally physiography of the reef-flat and steepness of beach deposits characterizes this coastline as a high energy environment. This is defined as a coastal area where wave action is consistently very strong. The reef-flat commonly exposes at low tide. There are large boulders on the reef-flat, which are frequently moved by wave action. In January, a large turbidity plume, caused by heavy rains discharging from a small stream, was observed. This facilitated in qualifying offshore current movement (Figure 3). There was a strong longshore current which moved the plume offshore. The high surf caused the turbid water to be moved back onto the reef-flat south of Malem. It can be anticipated that an effluent discharge plume would be subject to frequent back washing onto the reef-flat. Since Malem coastline is a high energy environment, a sewer outfall placed over the reef would be subject to breakage at the reef margin in storm periods. Therefore, a marine outfall for Malem is not a very feasible alternative.

Figure 3. Malem coastline and nearshore environments. A recommended location is shown for oxidation ponds. A small stream is shown near this area which could be used for oxidation pond effluent discharge.

The use of a marine outfall for effluent disposal in Malem is not a very feasible alternative. A pipe line over the reef margin would be prone to breakage. It is recommended that oxidation ponds be built for effluent disposal. The ponds should be built in the wetland area north of Malem (Figure 3). Discharge from these ponds would enter a small stream which currently empties from the wetland. Monitoring of effluent water quality in the stream would be necessary and can be done by the local environmental health office.

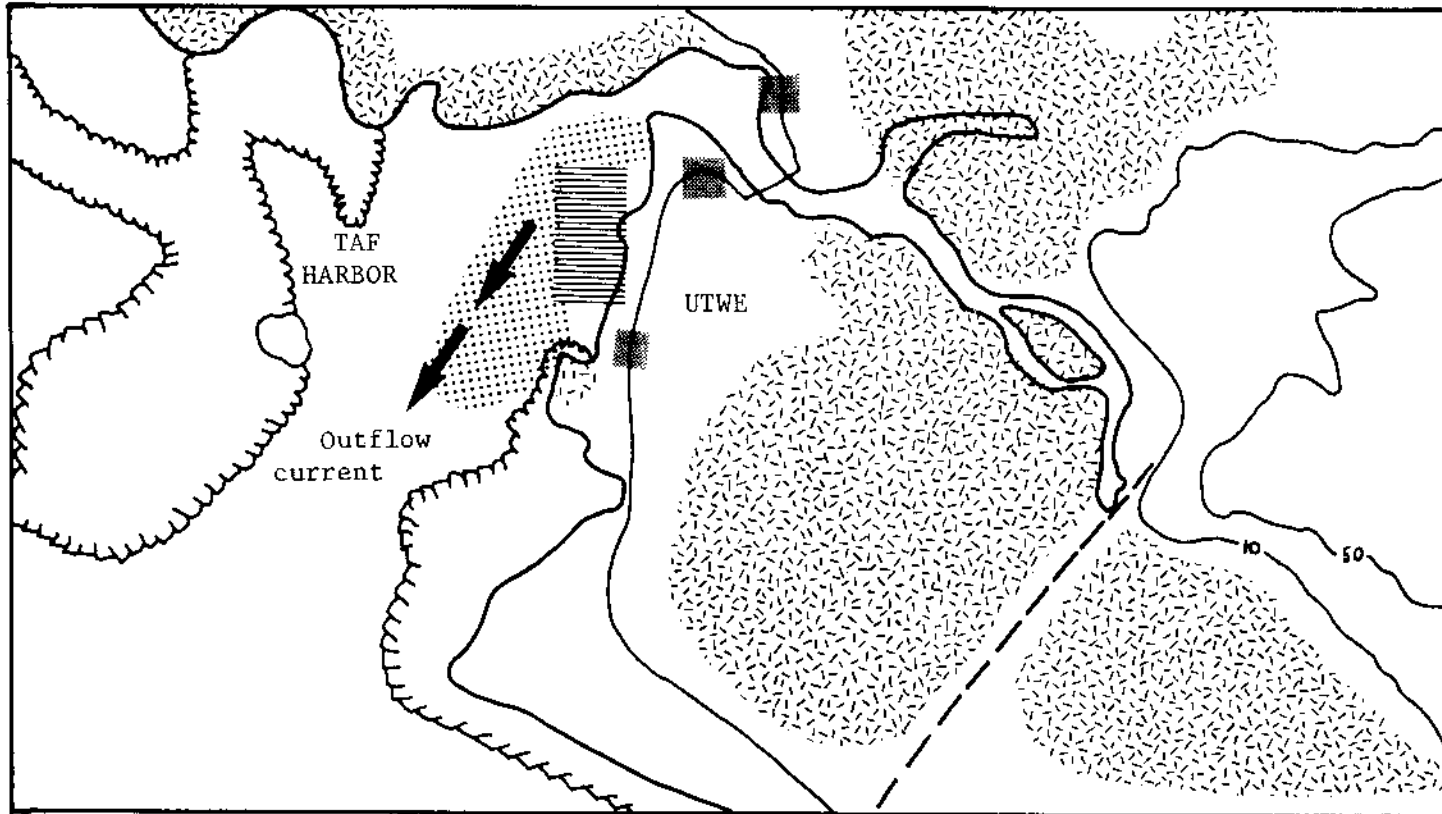
Figure 4. Utwe village coastline and dredge site. Mangrove swamp around village (blank area on map) shows extensive human induced changes.

being done by bucket crane using a moving ramp technique. This type of dredging operation produces turbidity plumes and siltation on adjacent reef systems. A turbidity plume was observed along the northern side of the harbor, extending toward the harbor mouth. This turbid water was washed onto the north side reef-flat and into a sparse mangrove zone adjacent to shore. The mangrove swamp surrounding Utwe village shows extensive man-induced alternations. There is considerable artificial filling, clear cutting of adjacent mangrove swamp and it contains a large quantity of debris and refuse.

The leaching field development as proposed for group core units (Videnov and Ludwig, 1983) will have minimal impact on the existing natural mangrove ecosystem. These leaching fields should provide a viable means of effluent disposal with minimal environmental impact at the proposed construction sites. This system can only help to improve sanitary conditions of mangrove swamp adjacent to Utwe.

The leaching field development designed for Utwe community will have minimal environmental impact on adjacent mangrove systems and coastal areas. These leaching fields should provide a viable means of effluent disposal.

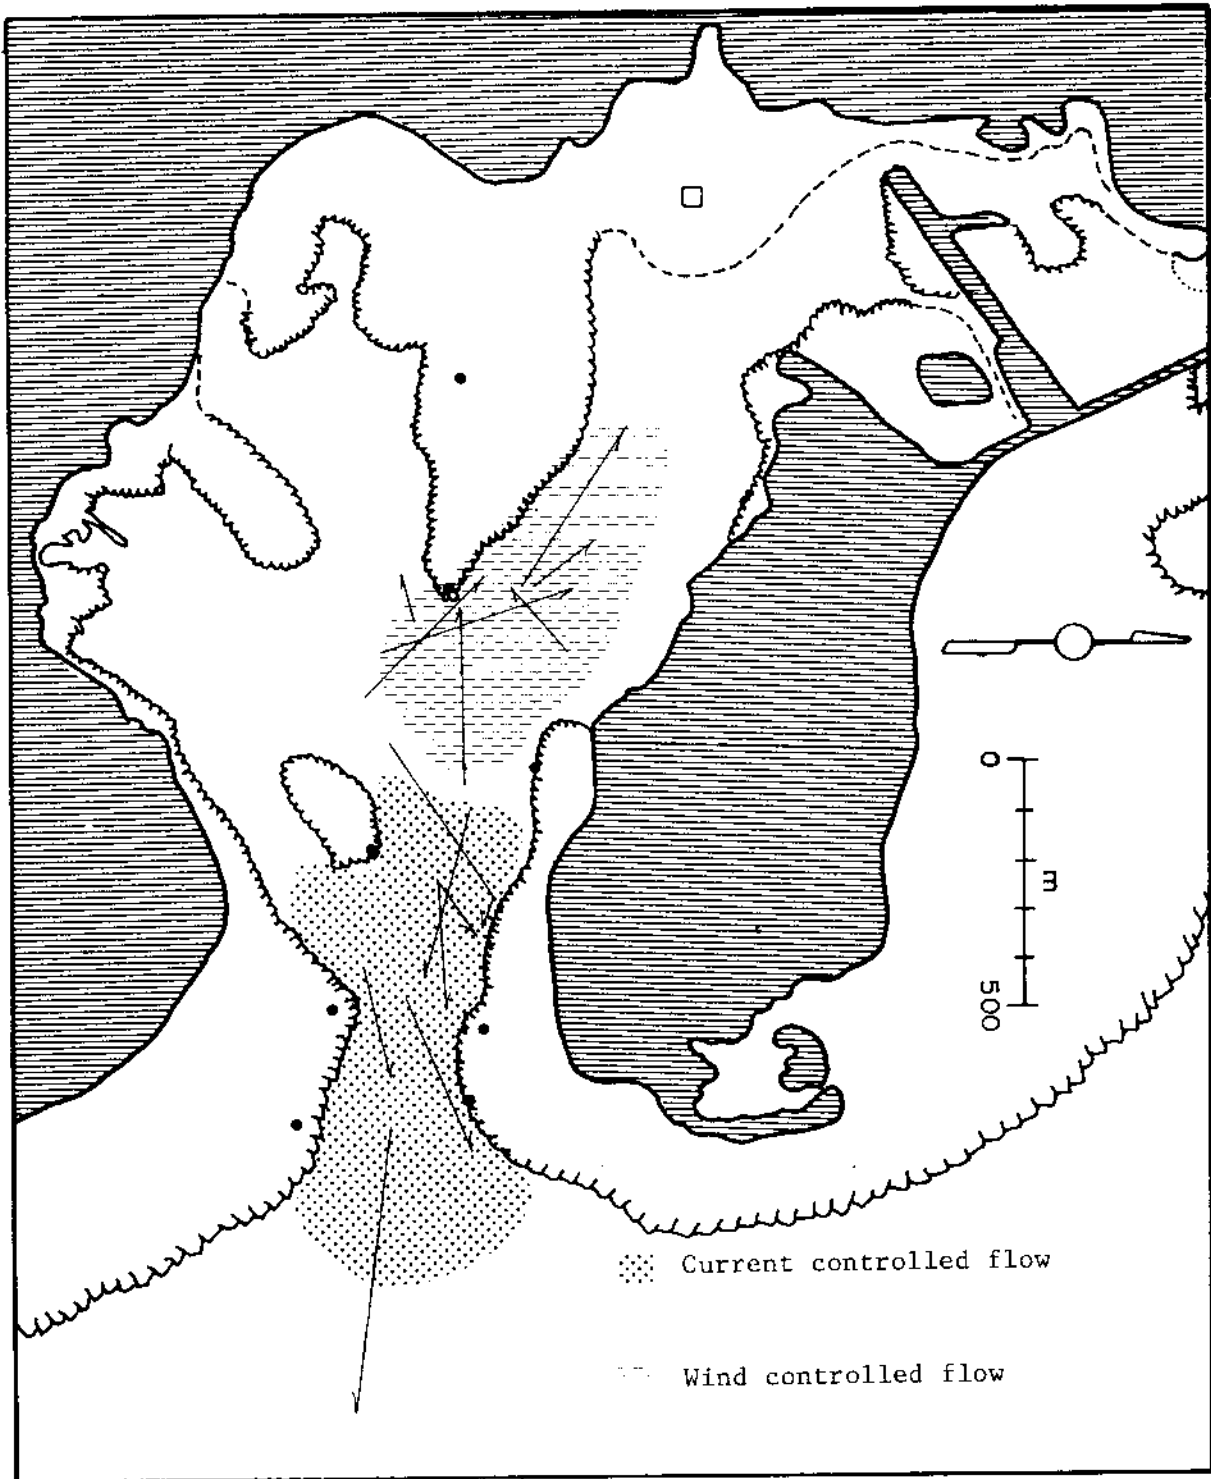
Current data were replotted, separating surface and subsurface water flow for both rising and falling tides. Surface water flow for falling tide shows an outward flow at the harbor mouth which negates east wind influence, while the west harbor surface water mass is wind driven (Figure 9). Current flow speed at the harbor mouth, particularly along the northern reef-flat, was substantially higher compared with a mid harbor surface water mass. Subsurface flow (at -5m) in falling tide showed a similar pattern to surface water (Figure 10). There was a strong outflow of water adjacent to the northern reef-flat. This subsurface flow generally moved southward after exiting the harbor. There was an inflow of subsurface water toward the western end of the harbor which also had a high flow speed. This flow speed was partly influenced by the strong east winds. Surface water mass during a rising tide showed a complex mixture of current and wind-driven flow patterns with high flow speeds (Figure 11). Water mass near the harbor entrance was current controlled and generally flowed outward. This water mass moved toward the northwest. The western harbor had a complex flow pattern controlled by deeper currents and surface winds. Toward neap tide this surface water mass moved with a very high flow speed toward the western mangrove system. Subsurface flow with a strong rising tide and strong east winds showed a net movement of water into the harbor (Figure 12). Current flow directions at similar times, were different (flow direction and speed) on the north and south sides of the harbor entrance. Inflowing subsurface water moved along the northern reef-flat, while outflow occurred along the southern reef-flat. This inflowing and outflowing system produced a large eddy complex in the south harbor. This south harbor subsurface water generally had lower flow speeds. In this area, surface and subsurface flow directions were as much as 180 degrees different. A few drift drogues were modified to measure a deeper subsurface water mass (-10m). This deeper water mass should have been below the zone of surface wind influence. Since there were difficulties with maintaining neutral buoyancy of surface floats, only 4 runs were made to measure deeper water flow (Figure 13). However, these drifts do provide some general flow characteristics. There is distinct layering of water masses in different portions of the harbor. In a rising tide along the northern harbor entrance, three water masses were observed which moved in different directions with different speeds (Figures 11 to 13). Surface water flowed out of the harbor, subsurface water at -5m showed strong inflow, and subsurface water at -10m showed strong outflow. There appeared to be a strong inflow of water deeper in the harbor entrance which flowed upward toward the central harbor and influenced current flow patterns in the western and southern portions of the harbor.

Figure 9. Water flow pattern of surface water with falling tide and east winds.

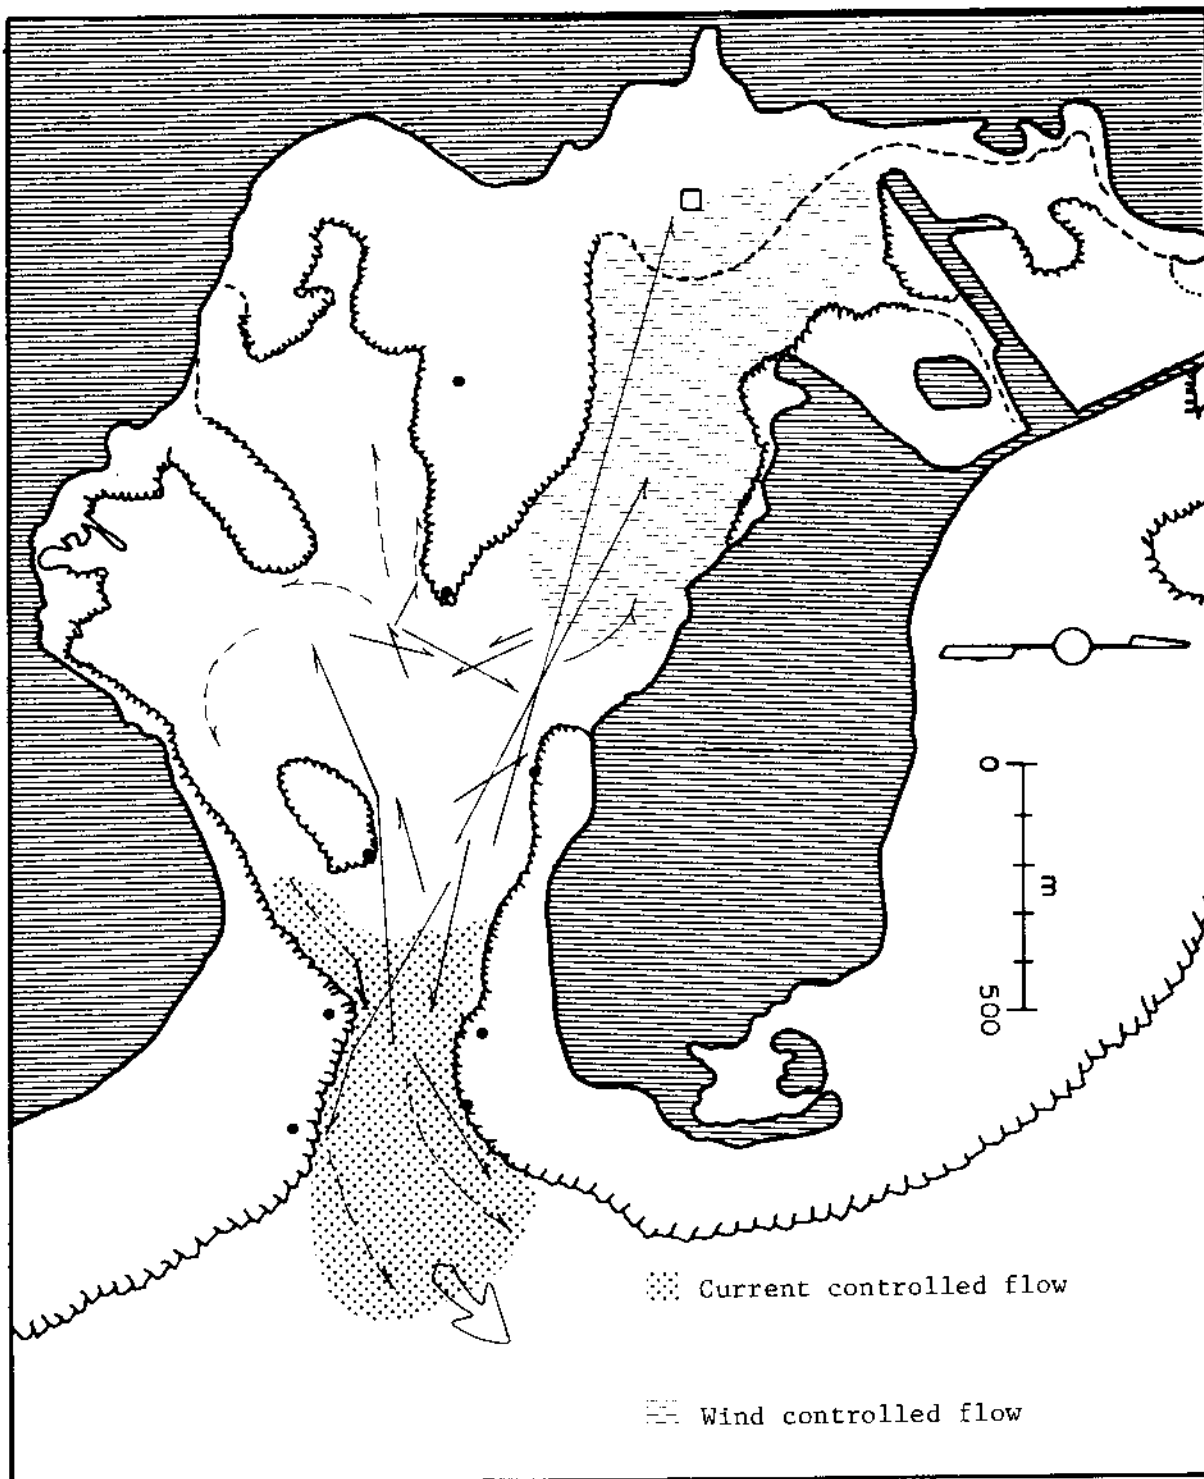
Figure 11. Water flow pattern of surface waters with rising tide and east winds. Back harbor water flow is influenced by a mixture of wind and current, while the harbor mouth is dominated by currents.

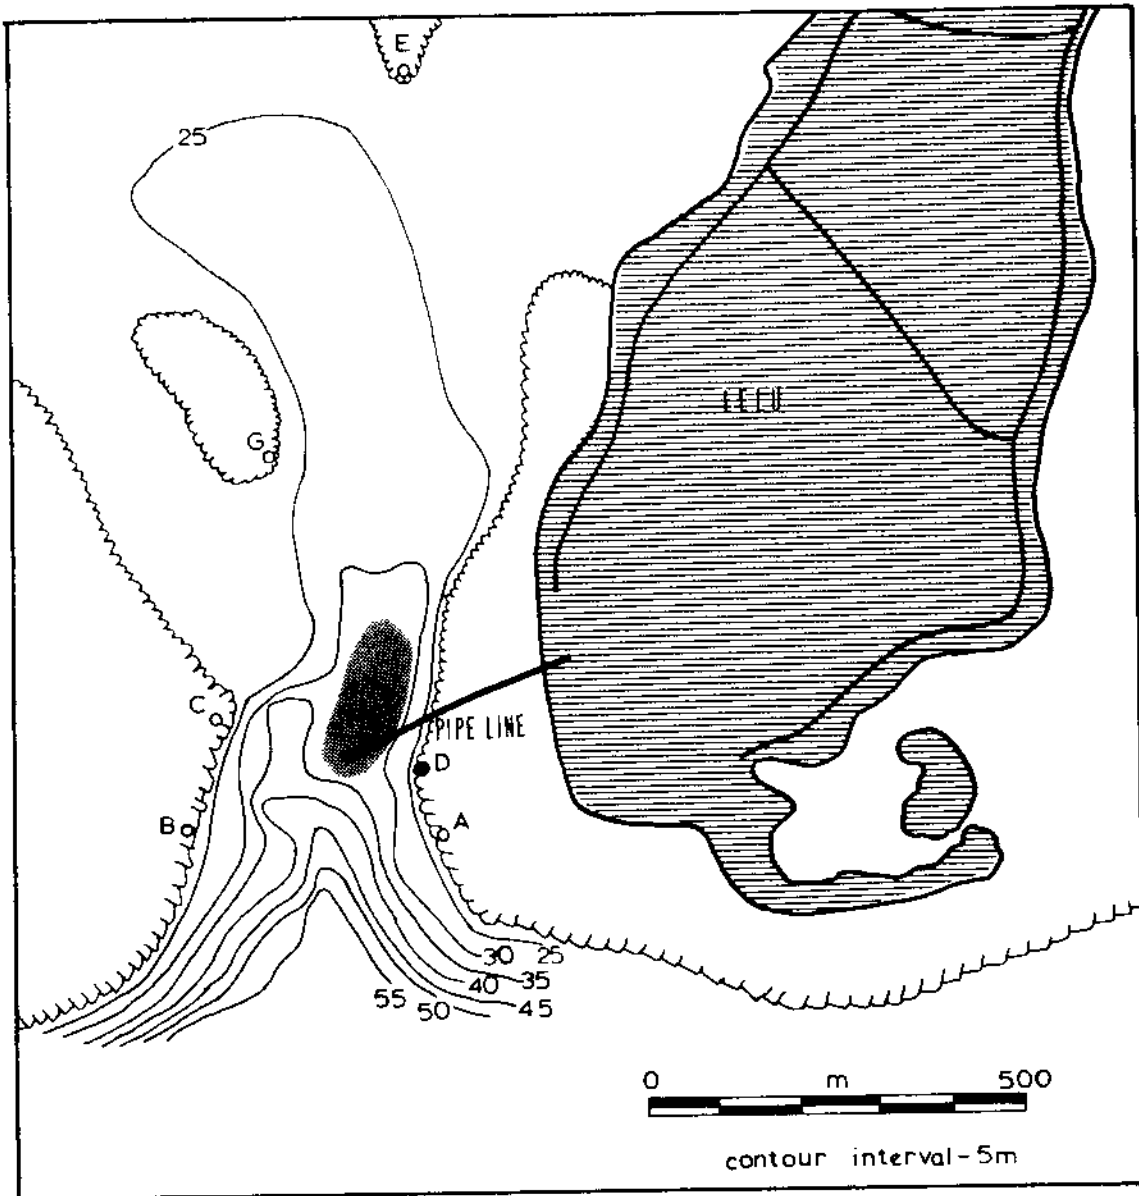
Figure 20. Recommended area for outfall discharge (cross-hatched area).
