LAND COVER CHANGE DETECTION IN SAIPAN

WATER AND ENVIRONMENTAL RESEARCH INSTITUTE
OF THE WESTERN PACIFIC
UNIVERSITY OF GUAM

Technical Report No. 149
September 2014

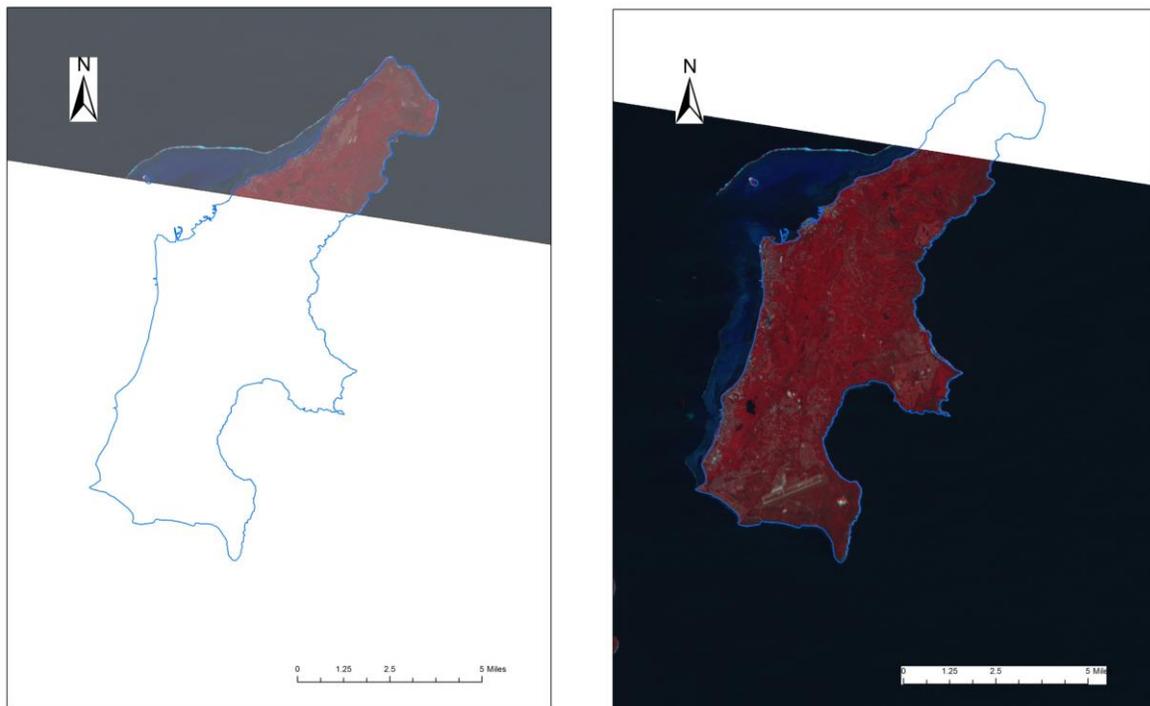
Figure 5. ASTER Images of December 10, 2009

The data quality of ASTER L1B imagery of 2009 was very good. However, both of these two scenes of ASTER images were needed to be mosaicked to cover the whole island of Saipan. One image only covered a small part of Saipan in the north (Figure 5, left), and another one covered most part of Saipan but missing a small part of the north (Figure 5, right).

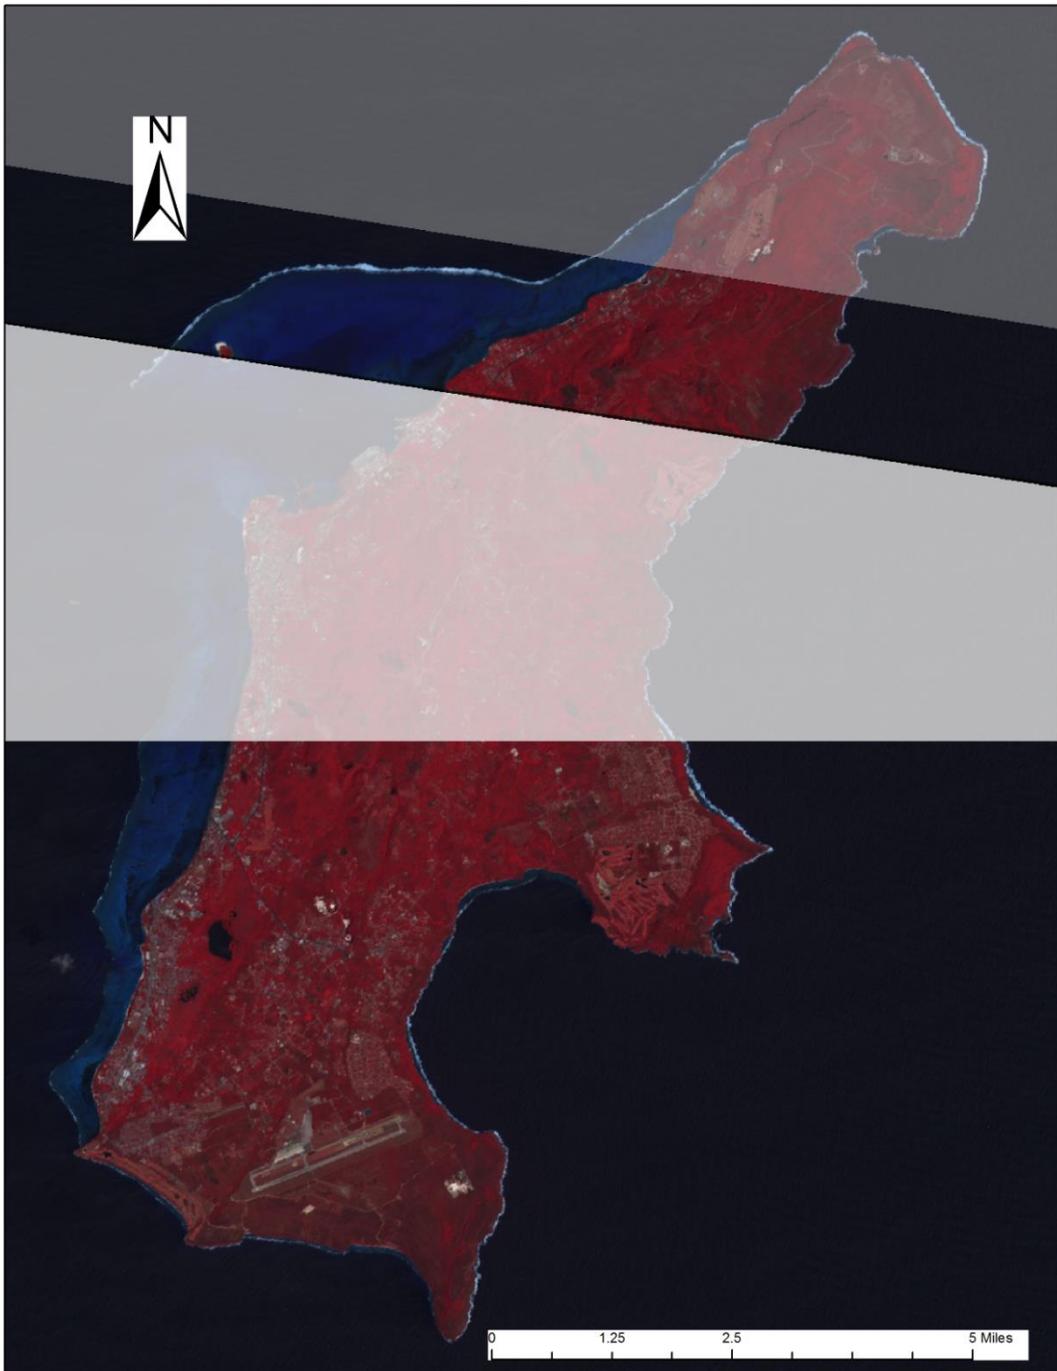
Figure 6. Overlapping of ASTER Images of 2009

ERDAS Imagine was utilized to mosaic the ASTER images of 2009. The overlapping of the ASTER images of 2009 indicated that they could cover the whole island of Saipan (Figure 6). The mosaicked ASTER image of March 5, 2009 is shown in Figure 7.

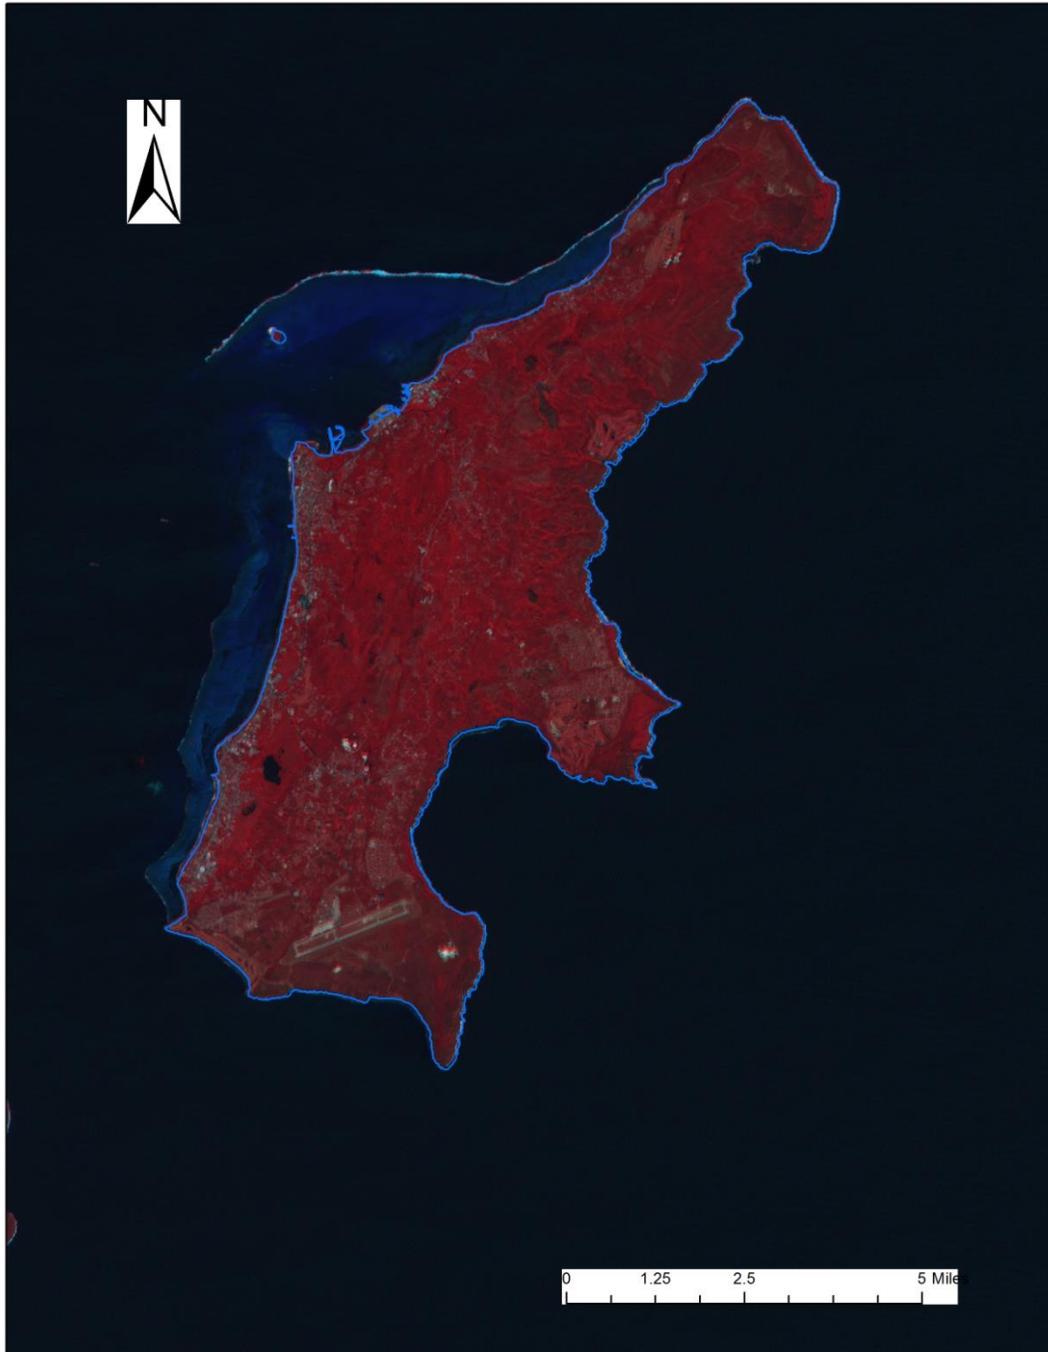
Figure 7. Mosaicked ASTER Image of March 5, 2009

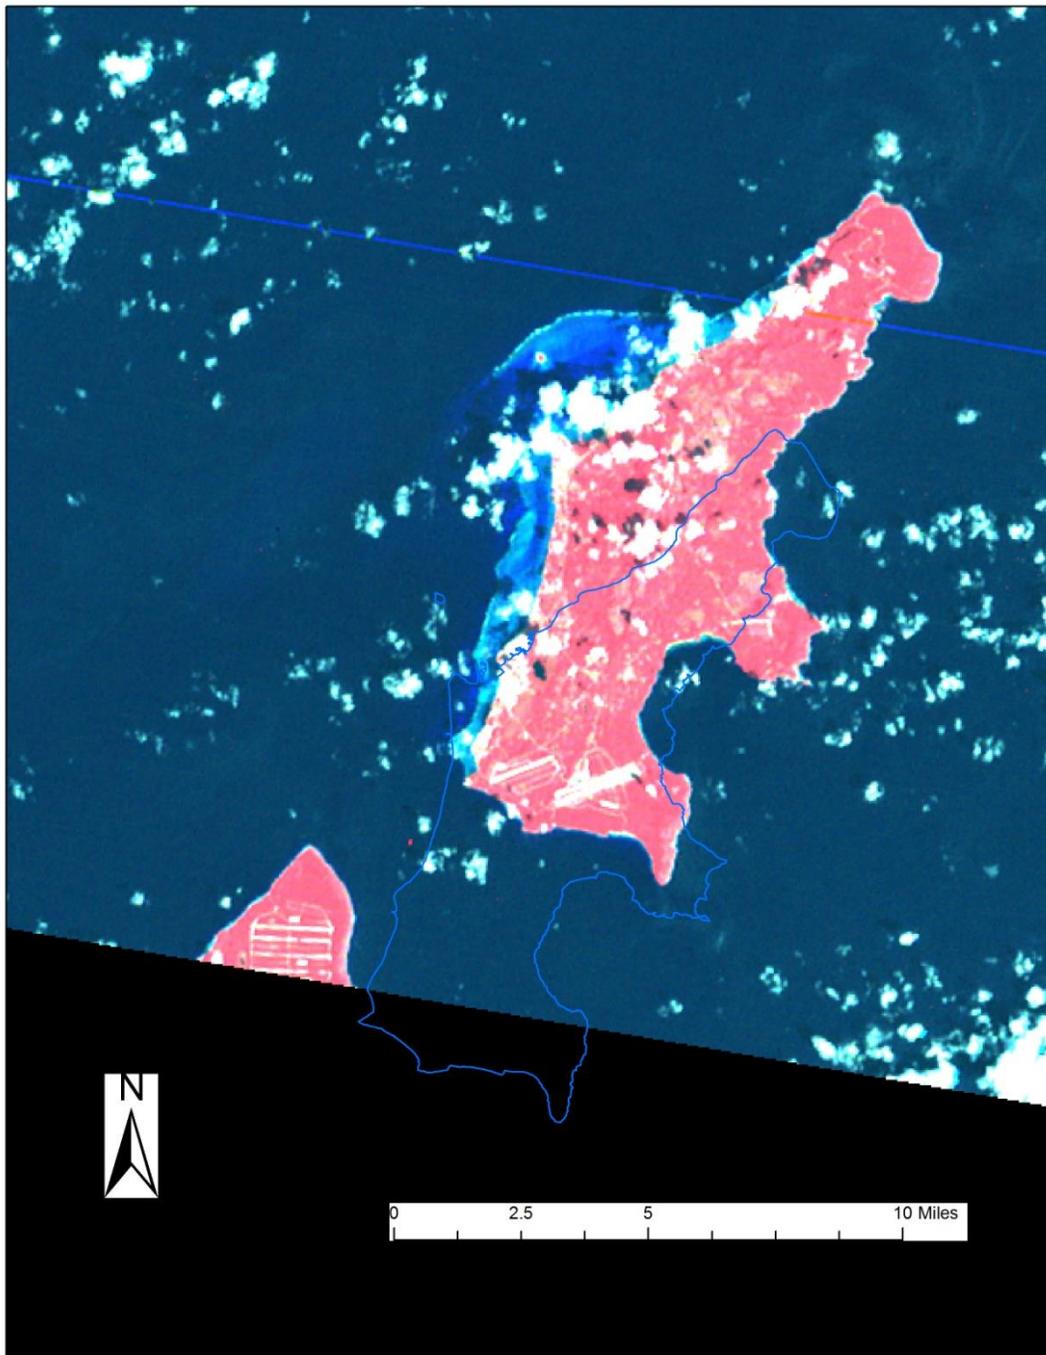
Figure 8. Landsat Multispectral Scanner (MSS) Image of October 17, 1978

The Landsat MSS satellite imagery of October 17 and December 10 of 1978 had problems with data quality since they were not located in the correct positions, and were covered by a lot of clouds and shadows (Figures 8 and 9). The boundary of Saipan is shown in blue, and obviously both of the Landsat MSS images of 1978 are displaced from Saipan. The Landsat image of

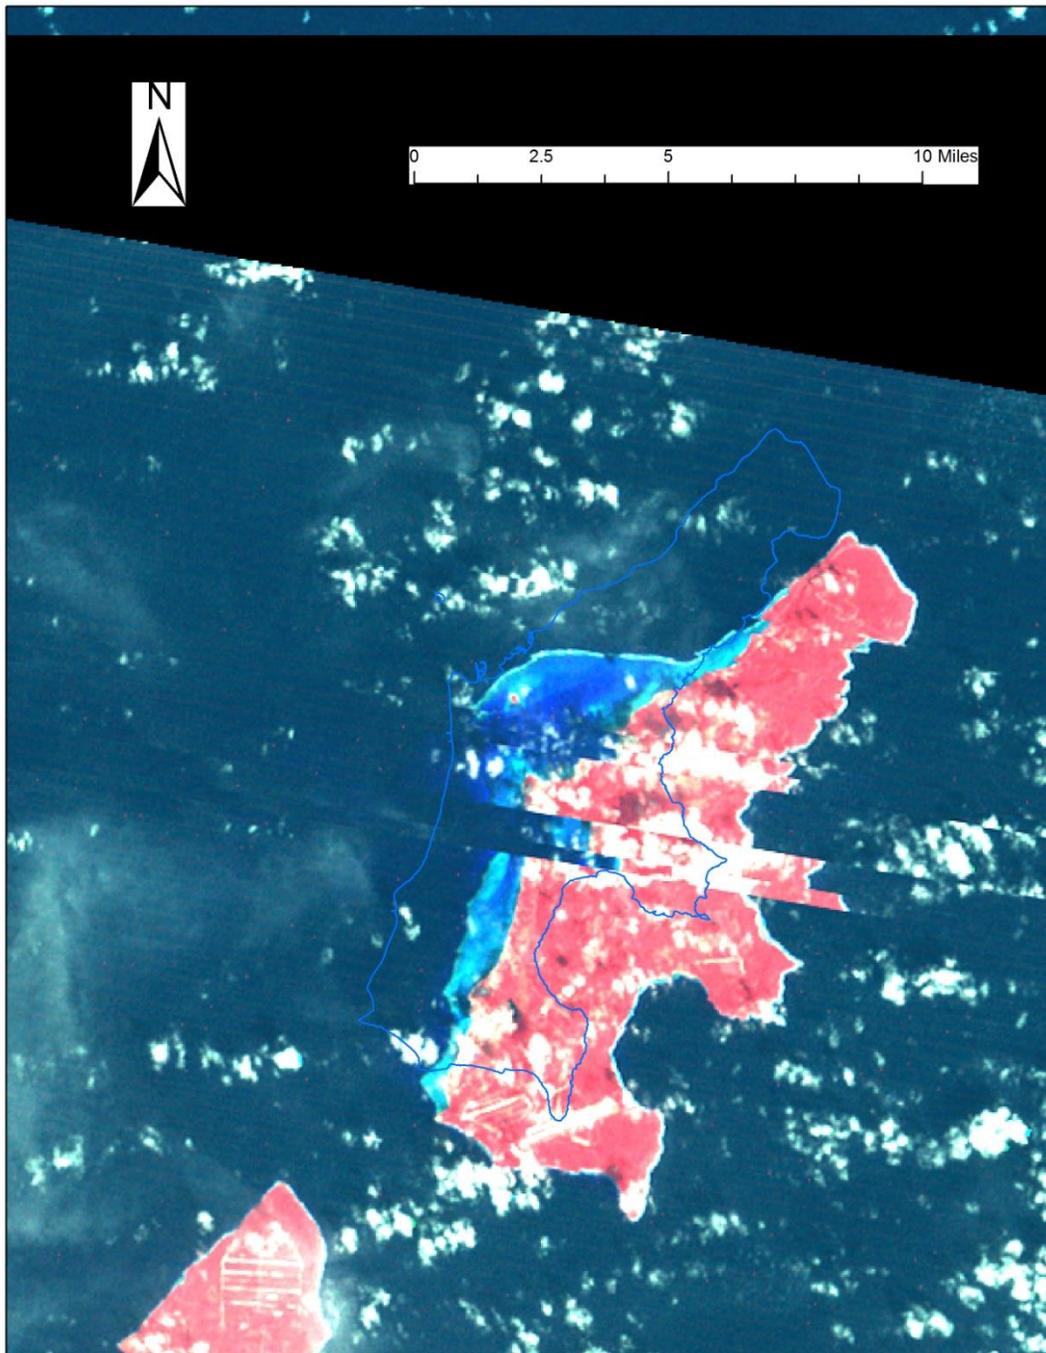
Figure 9. Landsat Multispectral Scanner (MSS) Image of December 10, 1978

December 10, 1978 got more problems. Some parts of the Landsat imagery of December 10, 1978 were displaced from their correct locations (Figure 9).

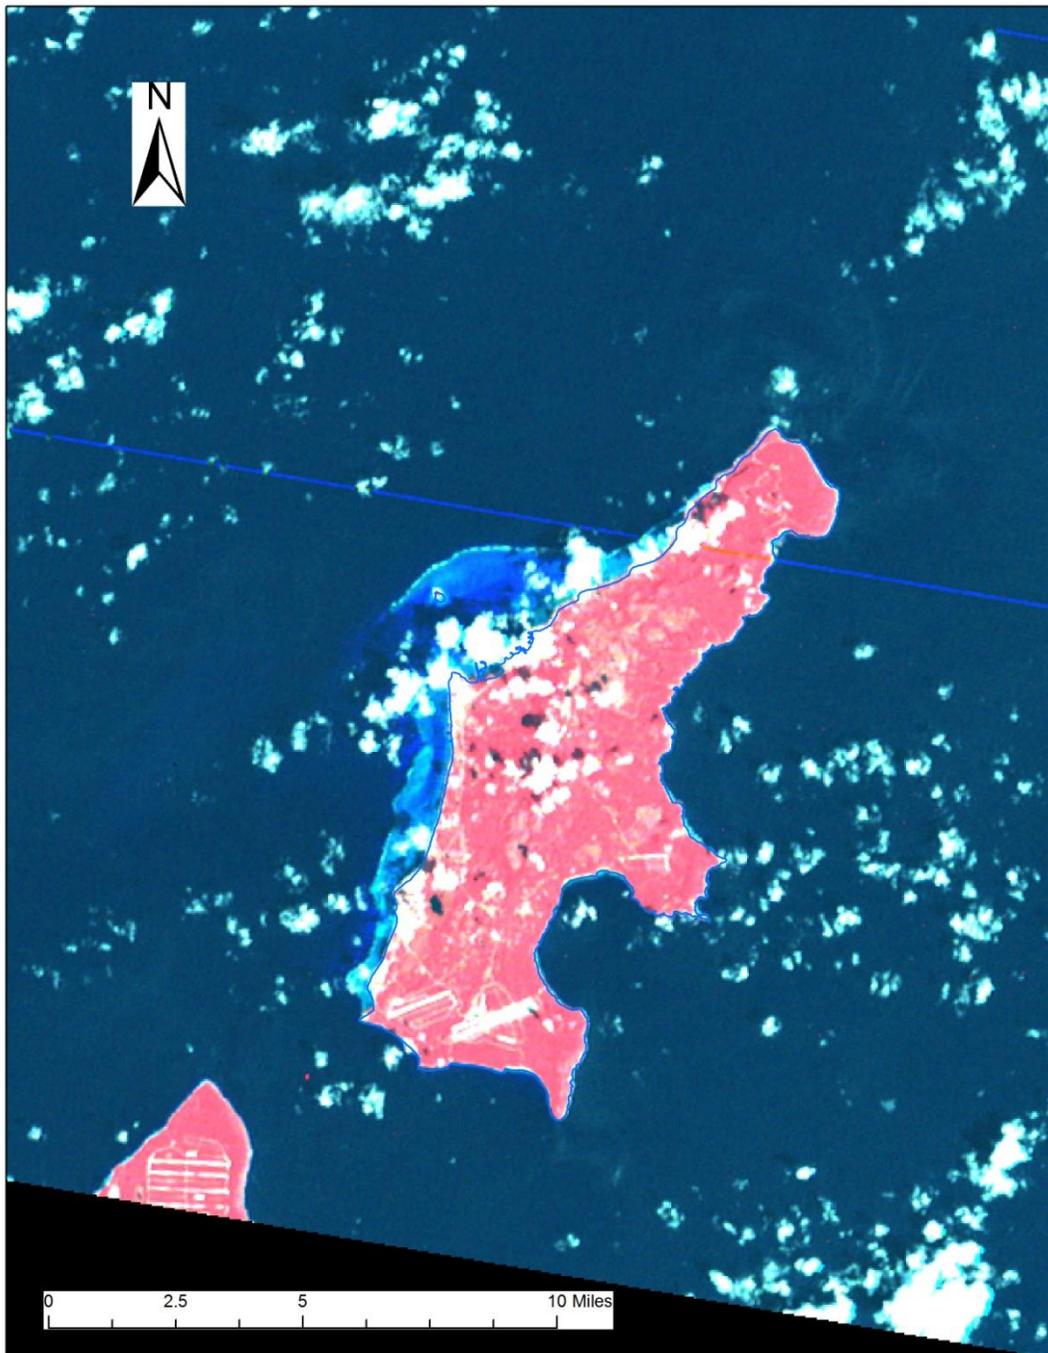
Figure 10. Georeferenced Landsat MSS Image of October 17, 1978

Georeferencing tool. The mosaicked ASTER image of 2009 was used as reference data for georeferencing. The georeferenced Landsat MSS images were shown in Figures 10 and 11.

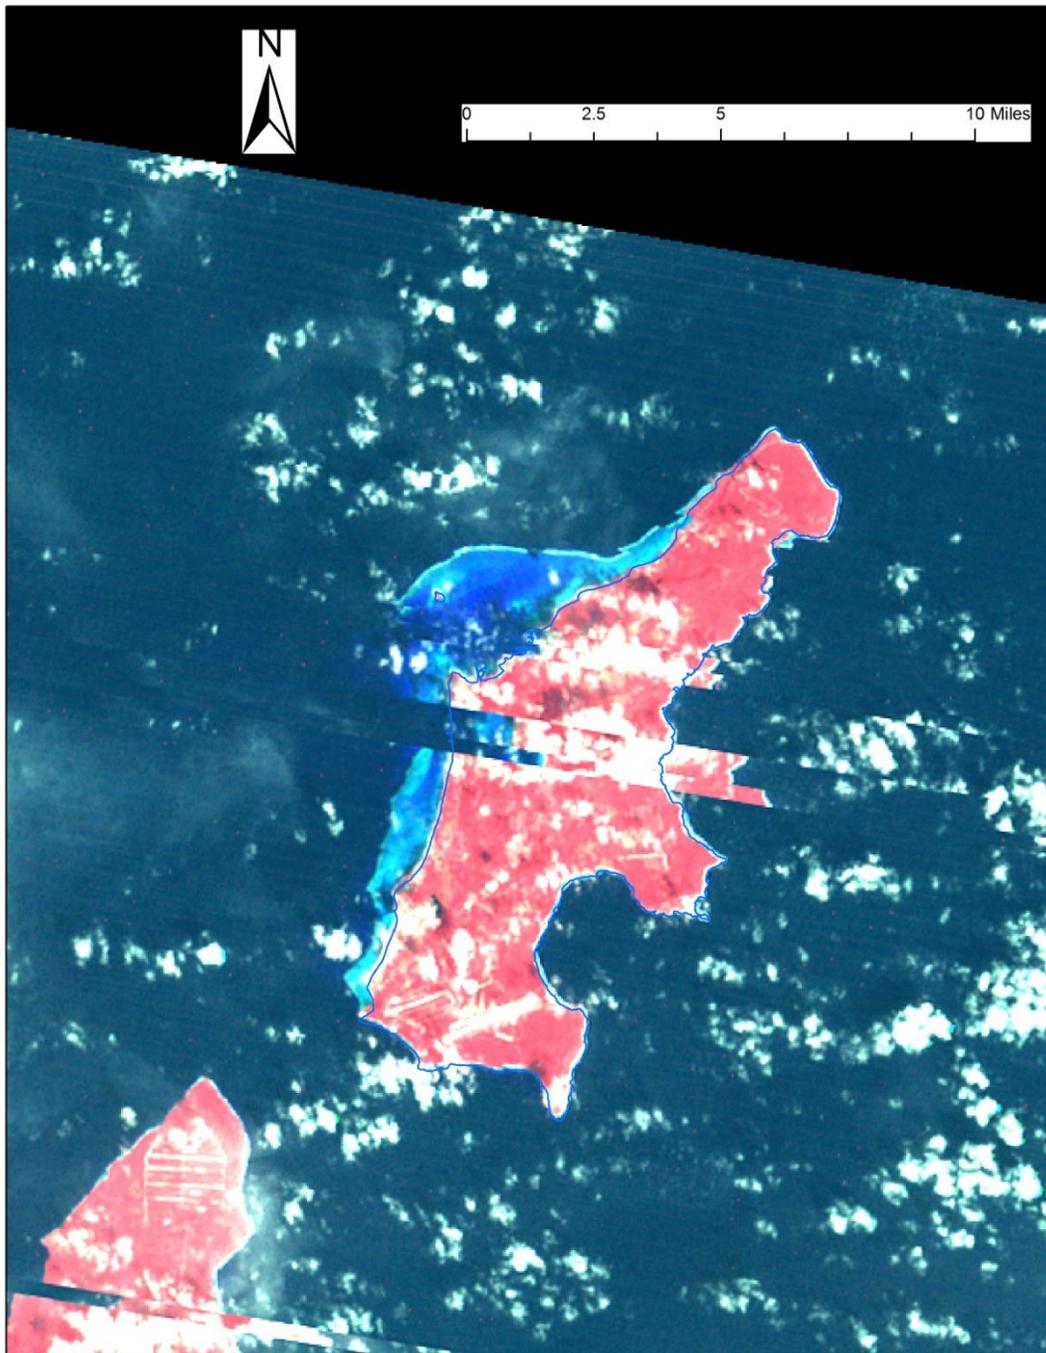
Figure 11. Georeferenced Landsat MSS Image of December 10, 1978

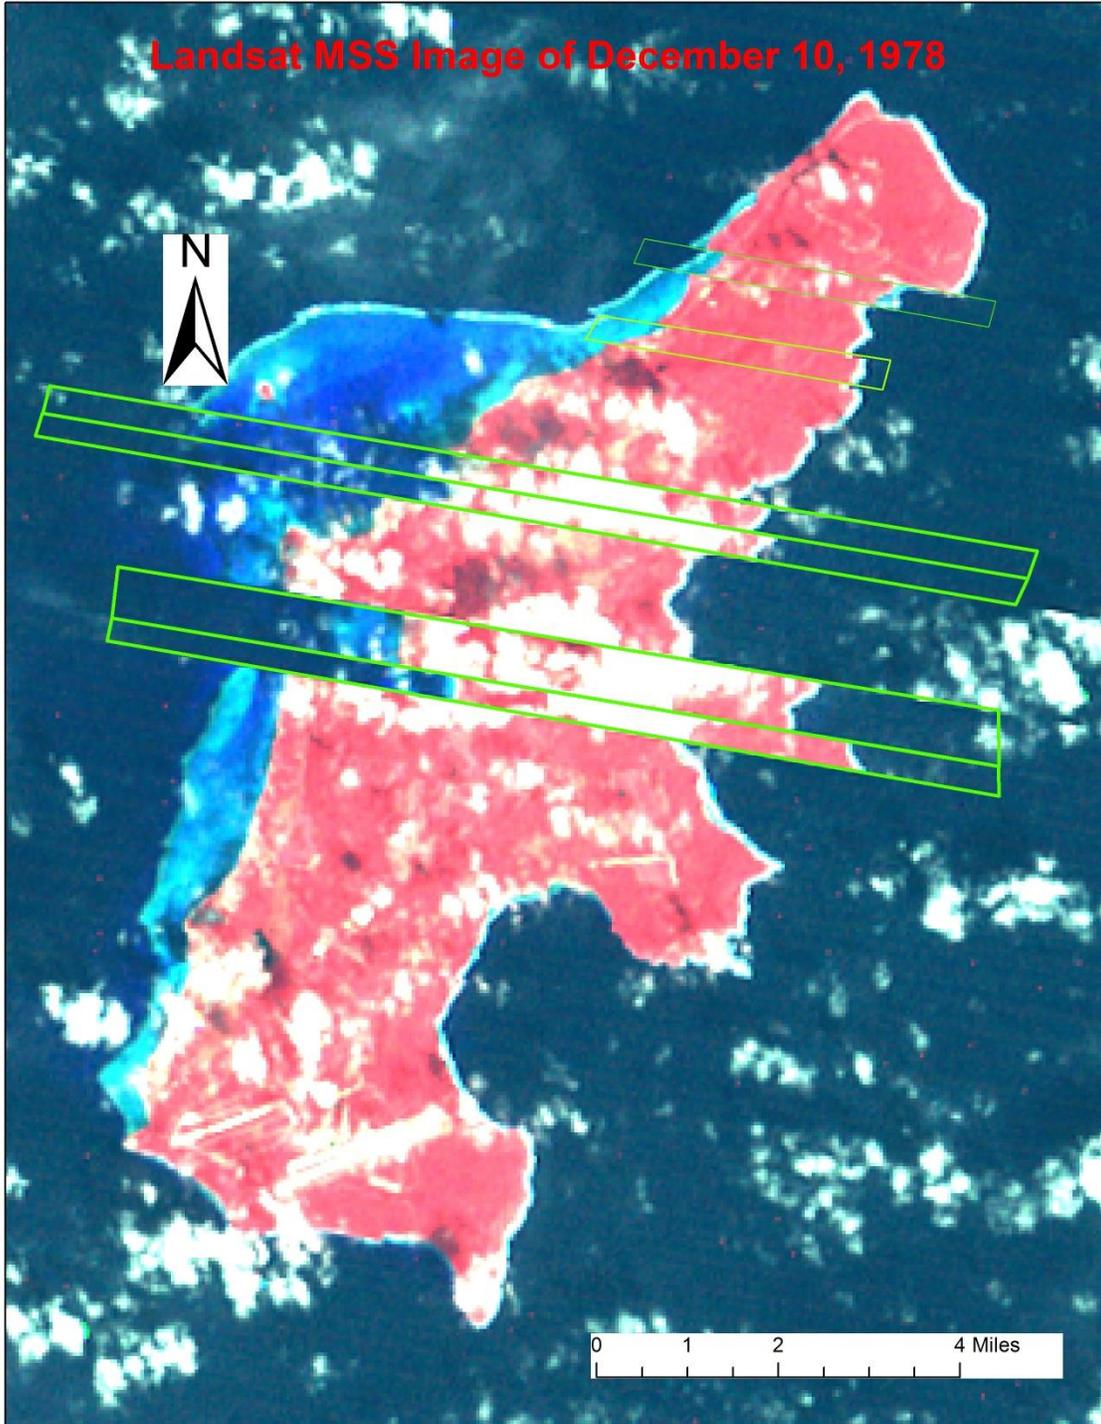
Figure 13. Locations of Displaced Parts of Landsat MSS Image of December 10, 1978

ArcGIS Desktop was used to locate the displaced parts (Figure 13), and ERDAS Imagine was used to extract the displaced parts from the original imagery of December 10, 1978 (Figure 14), and then ArcGIS Desktop was applied to georeference the displaced parts to correct locations (Figure 15). The georeferenced parts were applied to update the original imagery of December 10, 1978 (Figure 16).

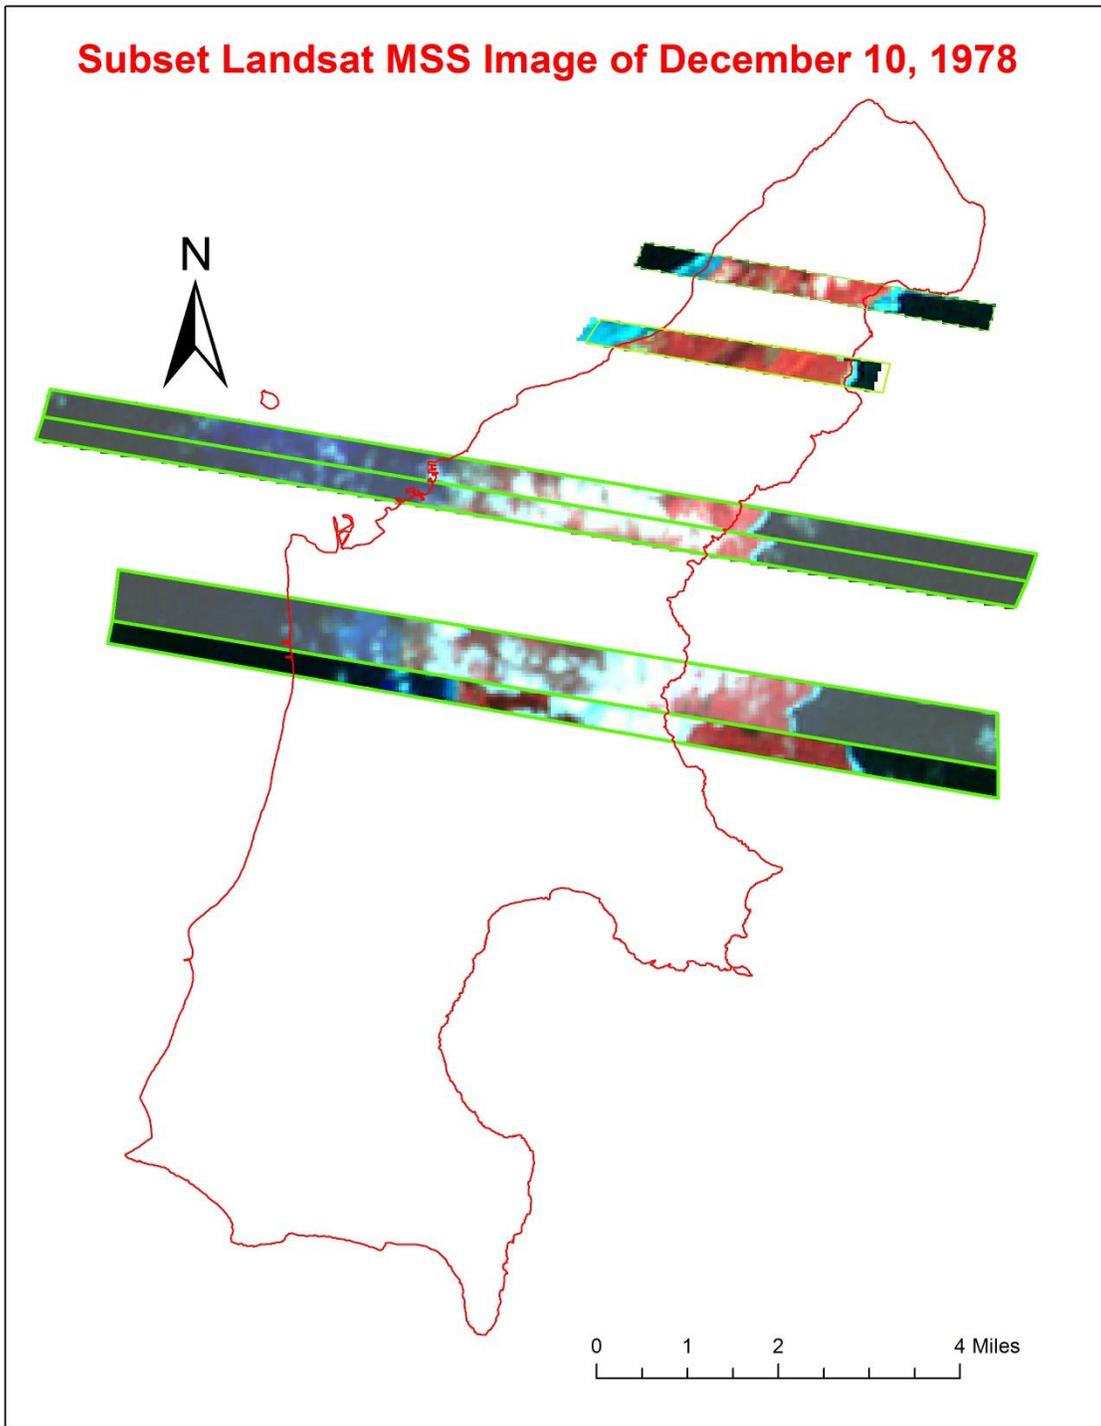
Figure 14. Subset Image of Displaced Parts from Landsat MSS Image of December 10, 1978

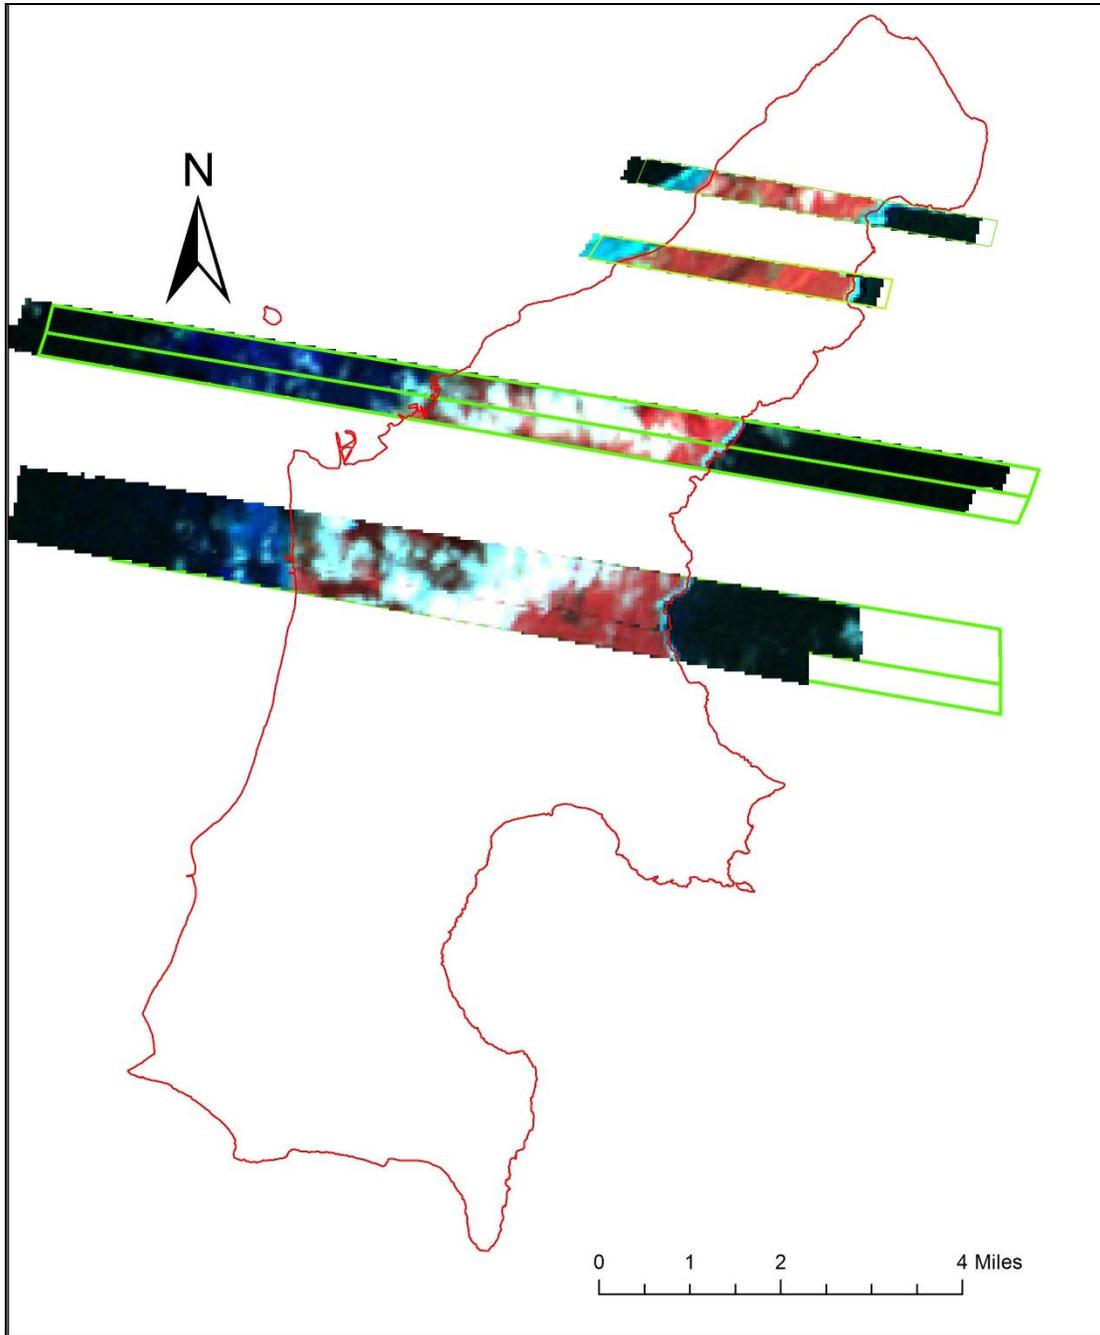
Figure 15. Georeferenced Subset Image of Displaced Parts from Image of December 10, 1978

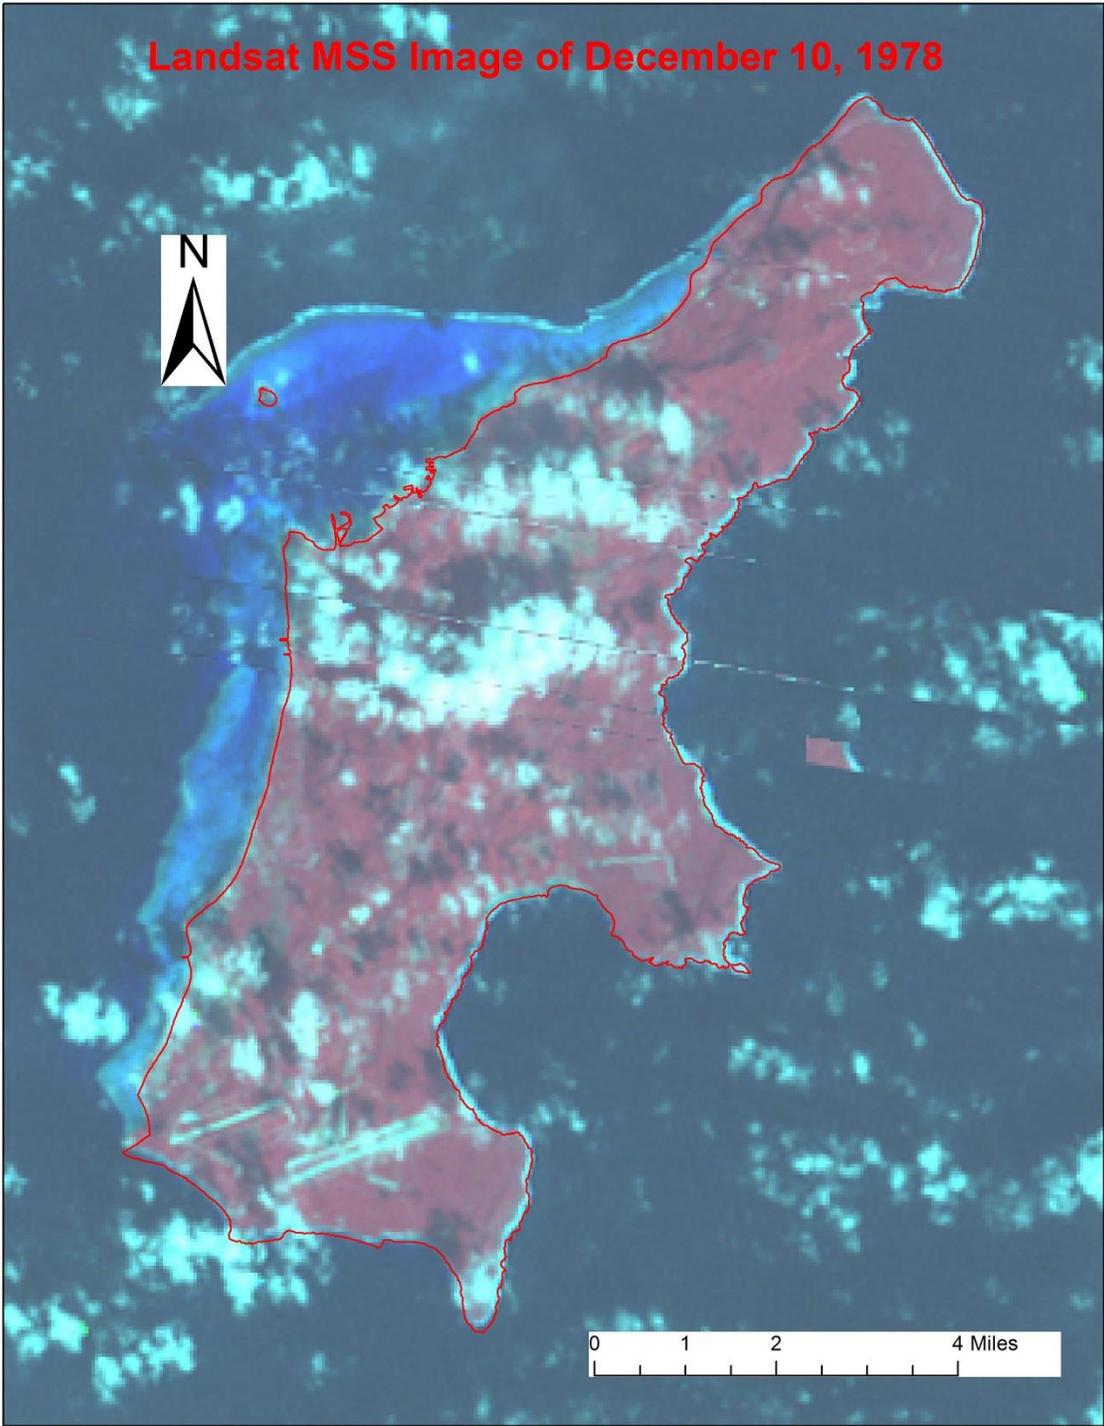
Figure 16. Georeferenced Image of December 10, 1978 with Displaced Parts Corrected

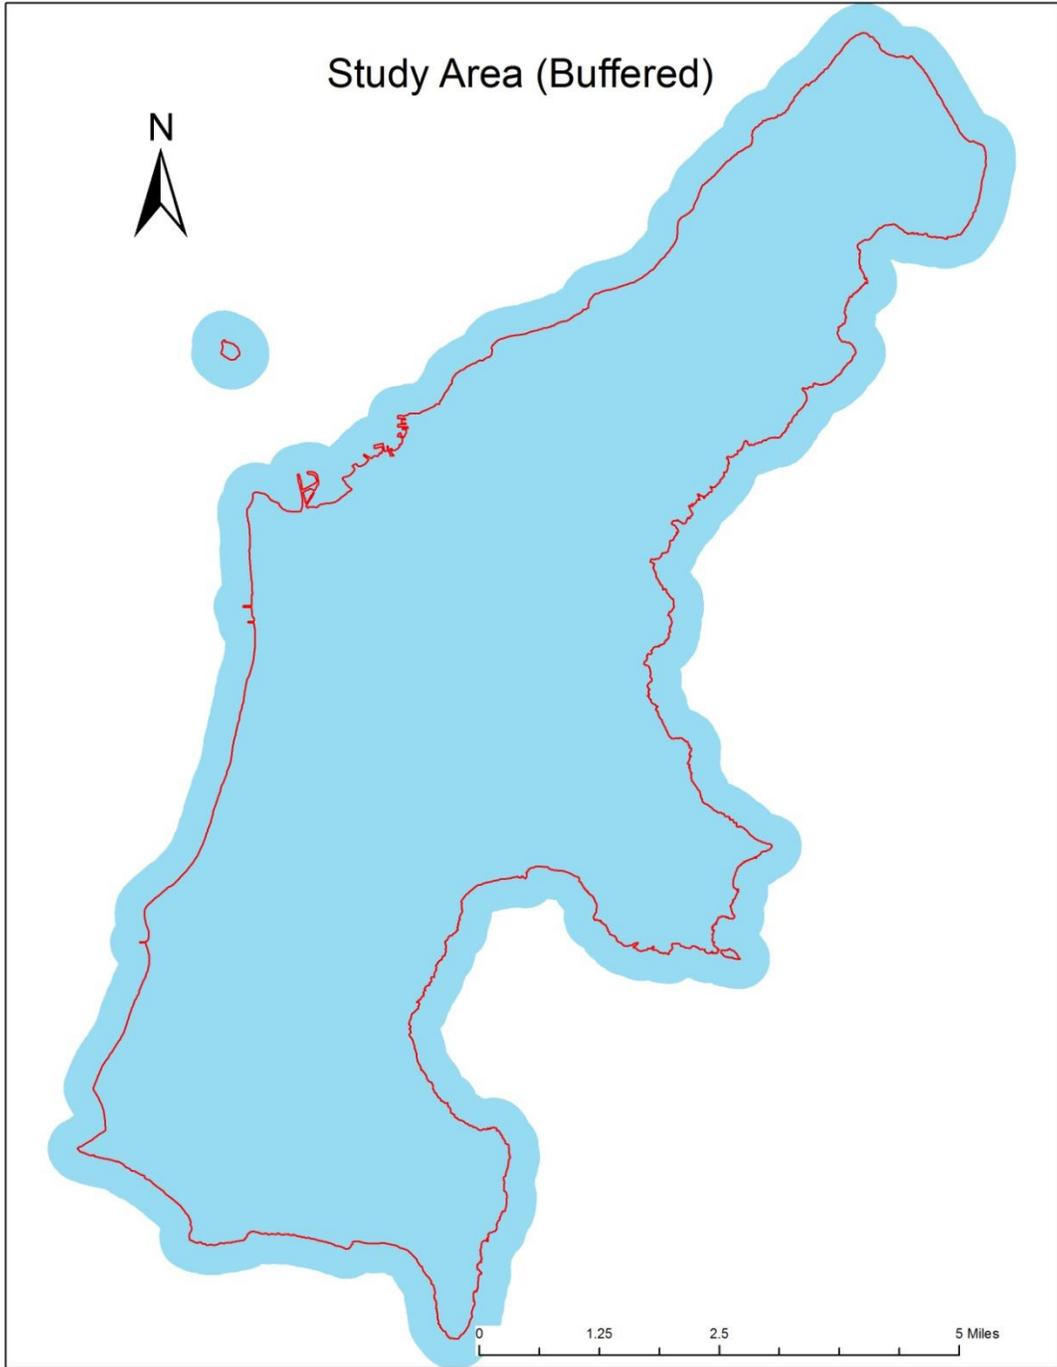
Figure 17. Buffered Study Area

Since the original satellite images used in the project covered a much bigger area. In order to process the data more efficiently, the boundary of study area (Figure 4) was used to subset the imagery for the purpose of land cover change detection in Saipan. ESRI ArcGIS Desktop was applied to buffer the study area for a bigger area to subset the satellite images so that the land cover classification accuracy along shoreline could be improved (Figure 17). Image subsetting was completed in ERDAS Imagine. The subset images for Landsat MSS images of October 17 and December 10, 1978, and ASTER image of 2009 are shown in Figures 18, 19 and 20 respectively.

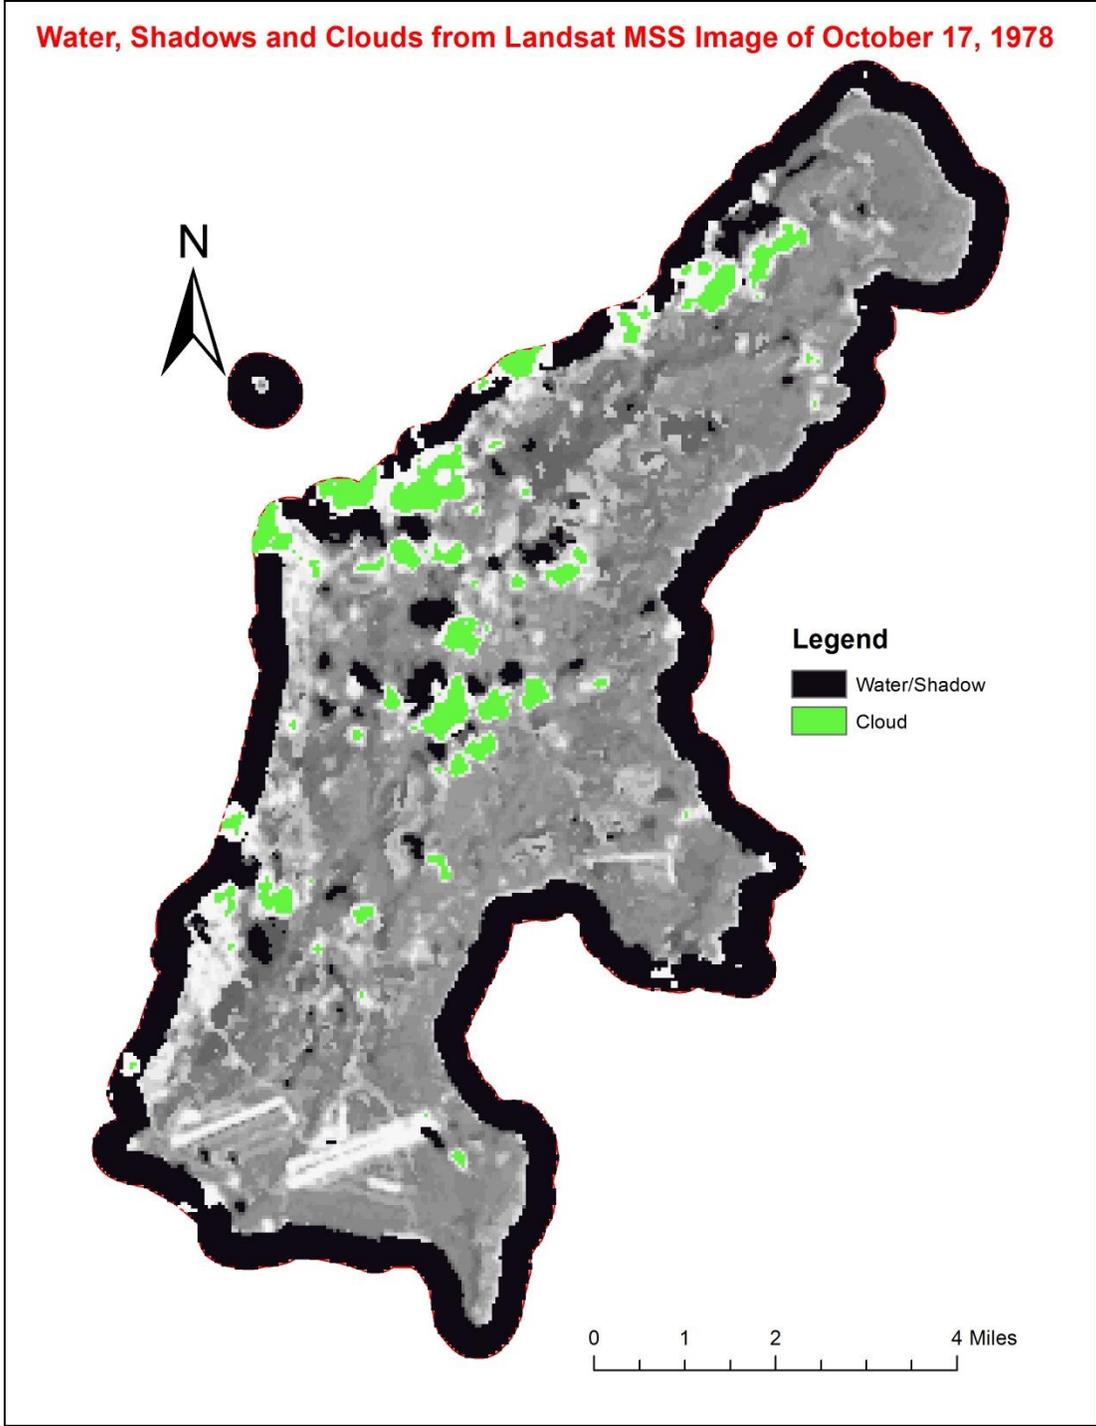
Figure 21. Water, Shadows and Clouds from Landsat Image of October 17, 1978

Figures 18 and 19 indicated that there were lots of clouds and shadows in the Landsat MSS images of 1978. In order to improve the accuracy of the land cover information derived from the Landsat MSS images, it was necessary to remove as many clouds and shadows as possible from the images. Since it was very difficult to differentiate between water and shadows, water was also removed in the beginning. The Landsat MSS images of 1978 indicated that the data quality of Landsat MSS image of October 17, 1978 was better than that of Landsat MSS image of December 10, 1978 because there were much more coverages of clouds and shadows in the latter image. The coverages of clouds, shadow and water from Landsat images of October 17, and December 10, 1978 were demonstrated in Figures 21 and 22 respectively. Such information was applied to remove clouds and shadows from Landsat MSS images of 1978 (Figures 23 and 24). Then the Landsat MSS image of October 17, 1978 was updated with the Landsat MSS image of December 10, 1978 with clouds and shadows removed (Figure 25), and the Landsat MSS image of December 10, 1978 was complemented with the Landsat MSS image of October 17, 1978 with clouds and shadows removed (Figure 26). The next step was to merge the Landsat MSS images of October 17 and December 10, 1978 with more clouds and shadows removed from the processed images listed in Figures 25 and 26, and the final Landsat MSS image of 1978 for land cover classification was achieved with much fewer clouds and shadows (Figure 27). So far, the Landsat MSS image of 1978 processed from Landsat MSS images of October 17 and December 10, 1978 with clouds and shadows removed and the mosaicked ASTER image of 2009 could be applied to extract land cover information. The images of Landsat MSS and ASTER are listed in Figure 28 side by side.

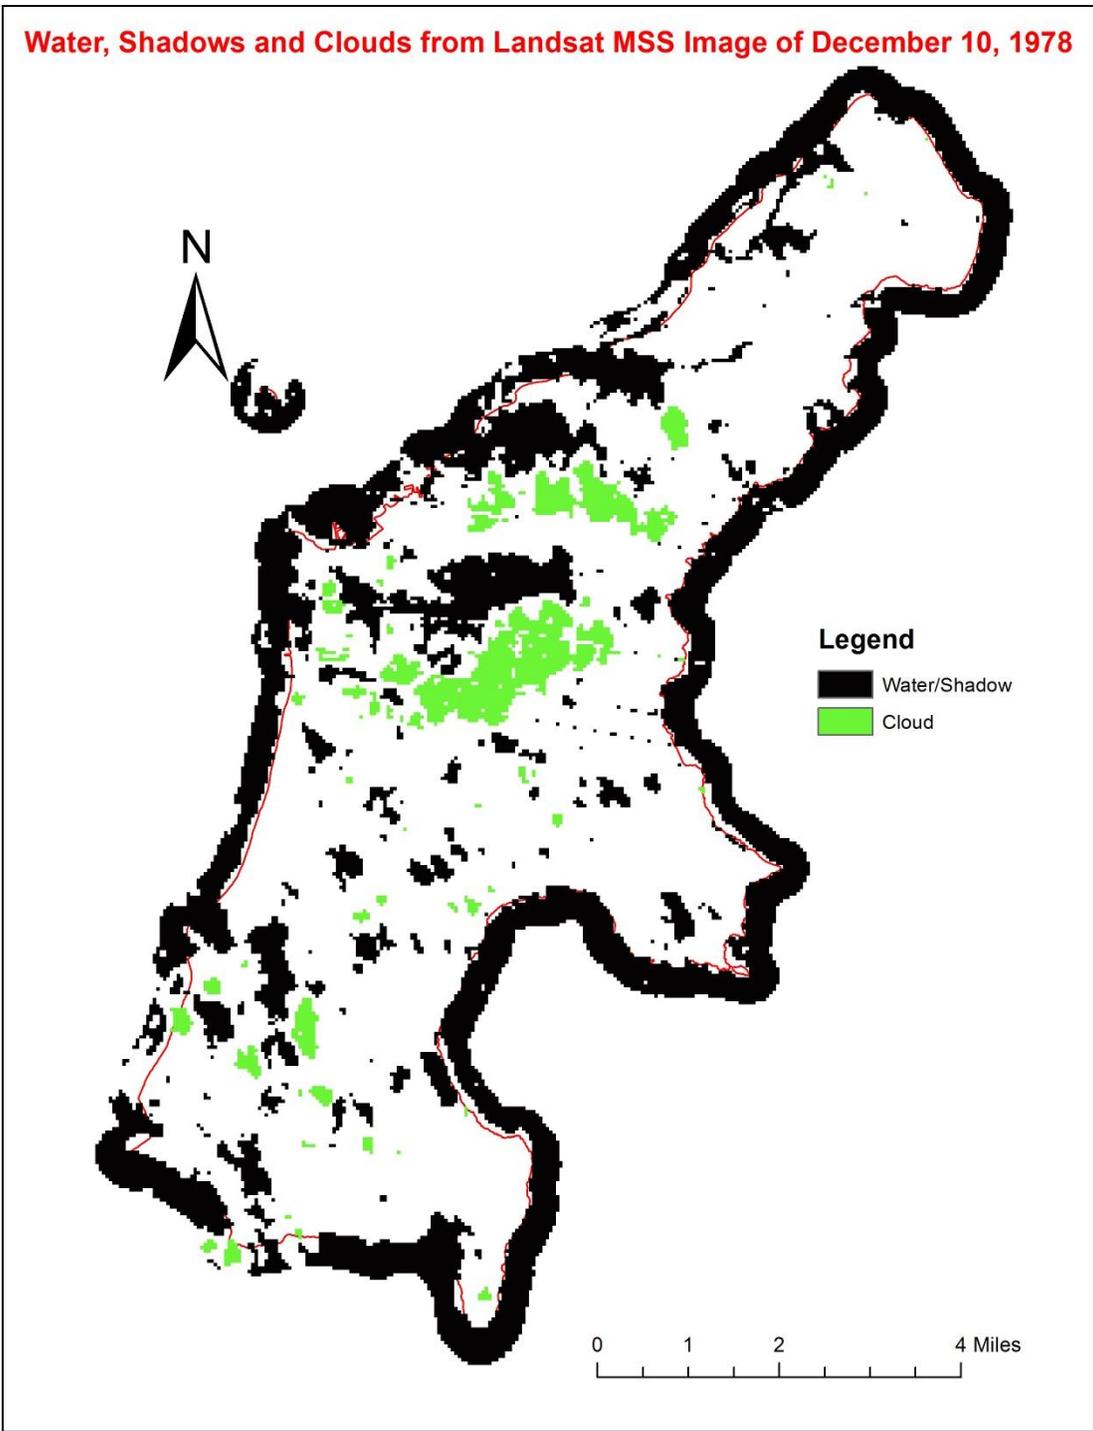
Figure 22. Water, Shadows and Clouds from Landsat Image of December 10, 1978
