LAND COVER CHANGE DETECTION IN SAIPAN

WATER AND ENVIRONMENTAL RESEARCH INSTITUTE
OF THE WESTERN PACIFIC
UNIVERSITY OF GUAM

Technical Report No. 149
September 2014

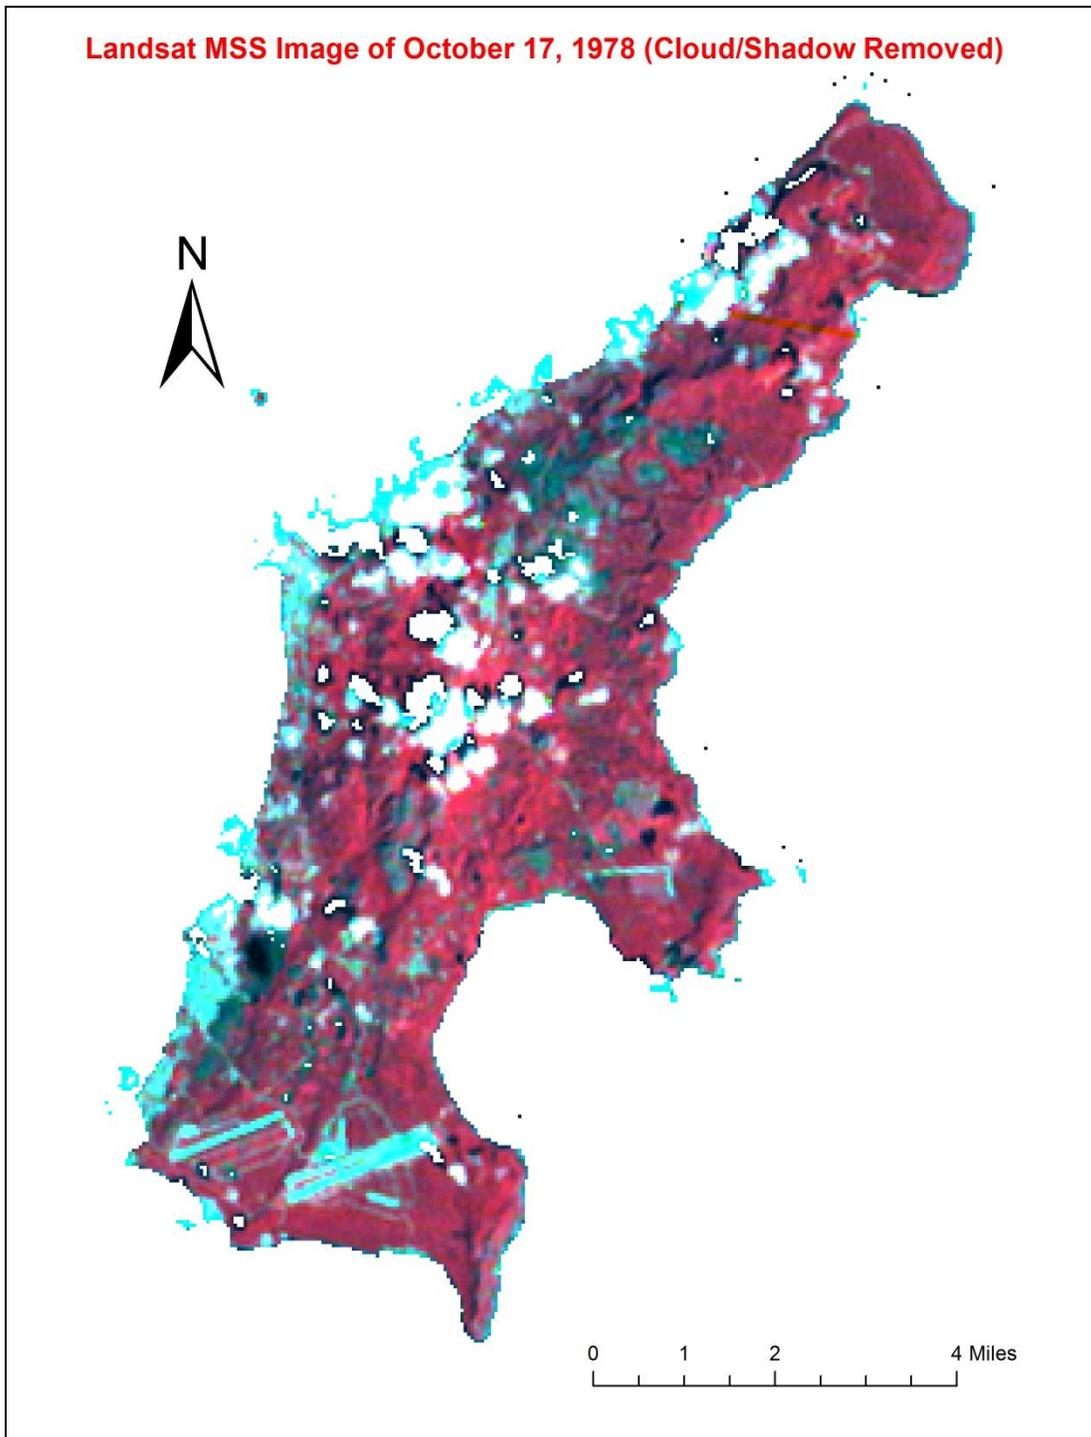
Figure 23. Landsat Image of October 17, 1978 with Water, Shadows and Clouds Removed

Figures 18 and 19 indicated that there were lots of clouds and shadows in the Landsat MSS images of 1978. In order to improve the accuracy of the land cover information derived from the Landsat MSS images, it was necessary to remove as many clouds and shadows as possible from the images. Since it was very difficult to differentiate between water and shadows, water was also removed in the beginning. The Landsat MSS images of 1978 indicated that the data quality of Landsat MSS image of October 17, 1978 was better than that of Landsat MSS image of December 10, 1978 because there were much more coverages of clouds and shadows in the latter image. The coverages of clouds, shadow and water from Landsat images of October 17, and December 10, 1978 were demonstrated in Figures 21 and 22 respectively. Such information was applied to remove clouds and shadows from Landsat MSS images of 1978 (Figures 23 and 24). Then the Landsat MSS image of October 17, 1978 was updated with the Landsat MSS image of December 10, 1978 with clouds and shadows removed (Figure 25), and the Landsat MSS image of December 10, 1978 was complemented with the Landsat MSS image of October 17, 1978 with clouds and shadows removed (Figure 26). The next step was to merge the Landsat MSS images of October 17 and December 10, 1978 with more clouds and shadows removed from the processed images listed in Figures 25 and 26, and the final Landsat MSS image of 1978 for land cover classification was achieved with much fewer clouds and shadows (Figure 27). So far, the Landsat MSS image of 1978 processed from Landsat MSS images of October 17 and December 10, 1978 with clouds and shadows removed and the mosaicked ASTER image of 2009 could be applied to extract land cover information. The images of Landsat MSS and ASTER are listed in Figure 28 side by side.

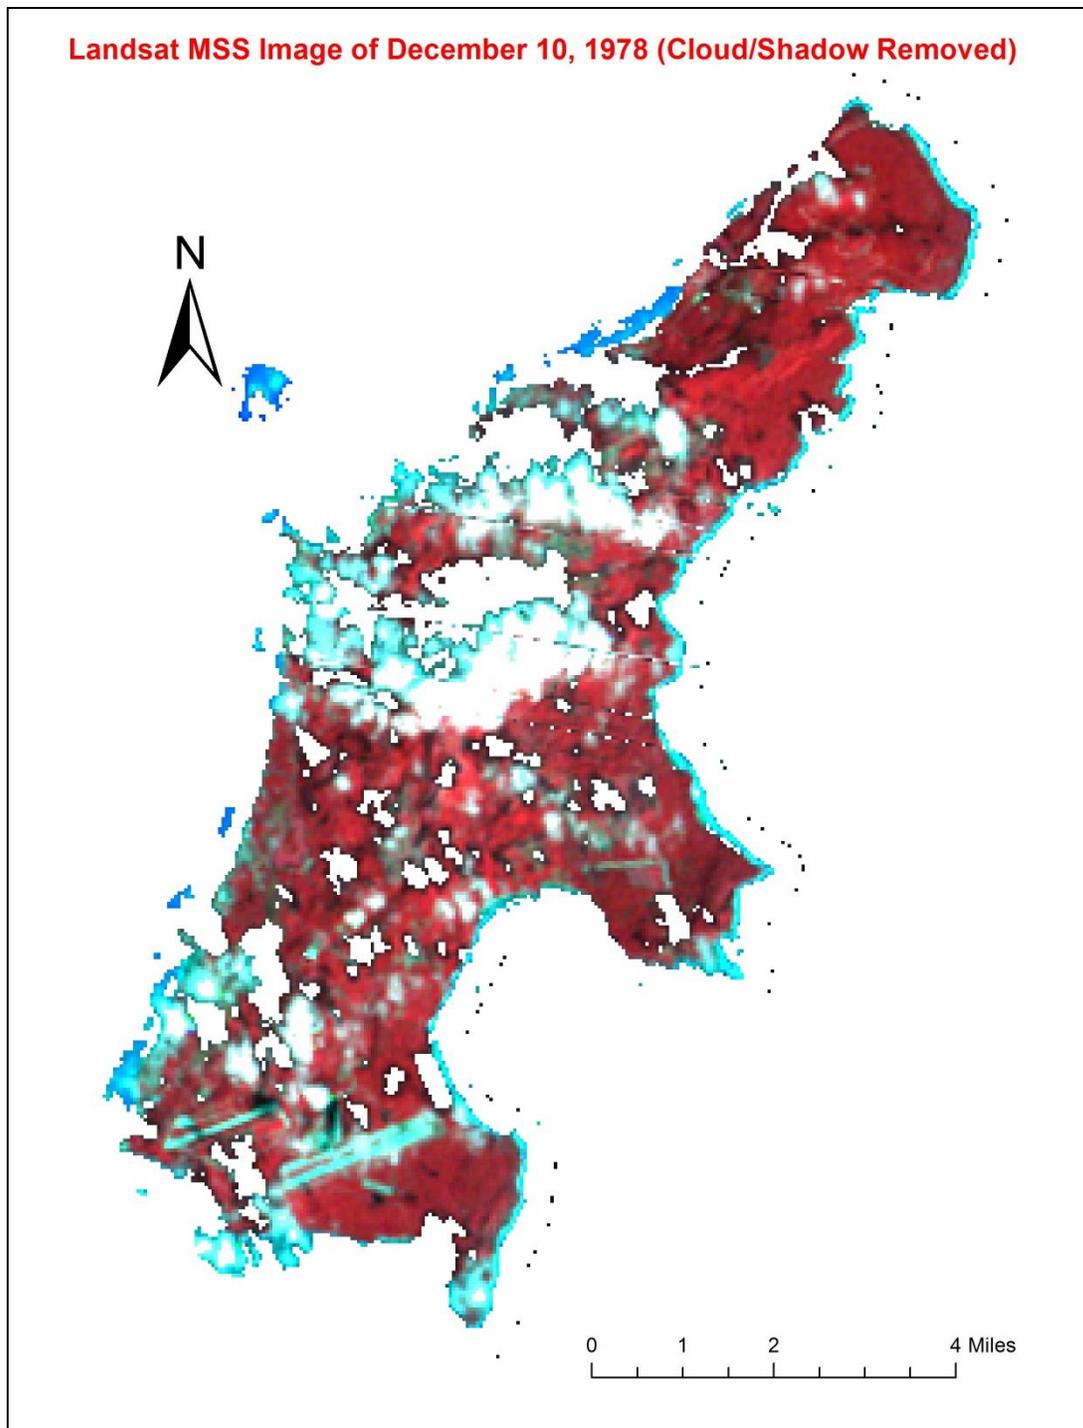
Figure 24. Landsat Image of December 10, 1978 with Water, Shadows and Clouds Removed

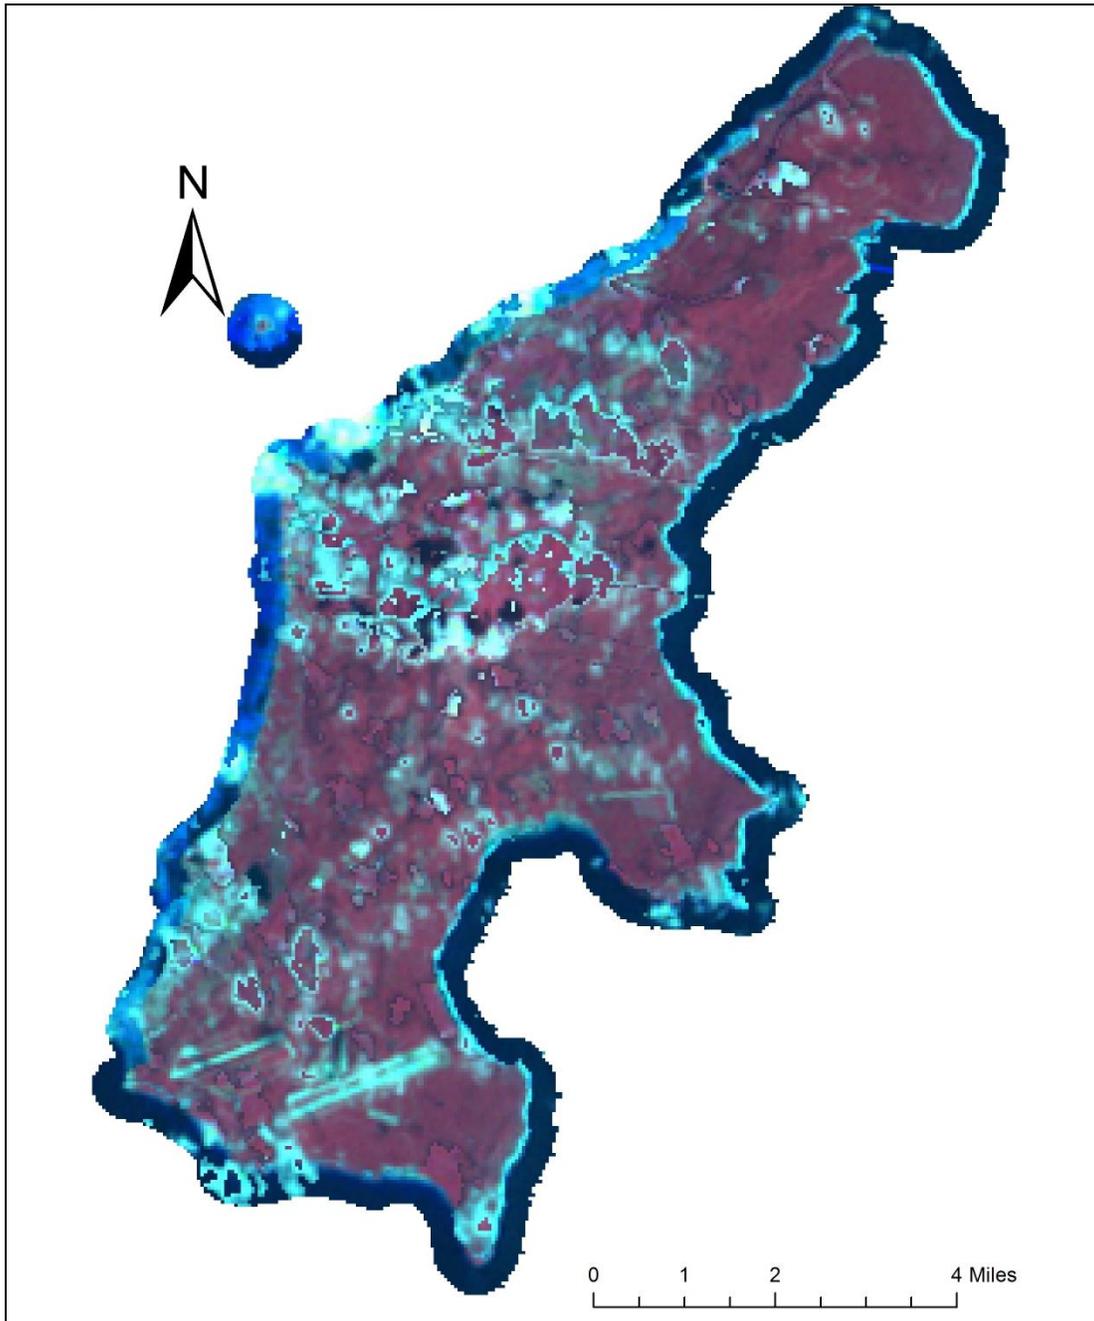
Figure 25. Landsat MSS image of October 17, 1978 was updated with Landsat MSS image of December 10, 1978 with clouds and shadows removed

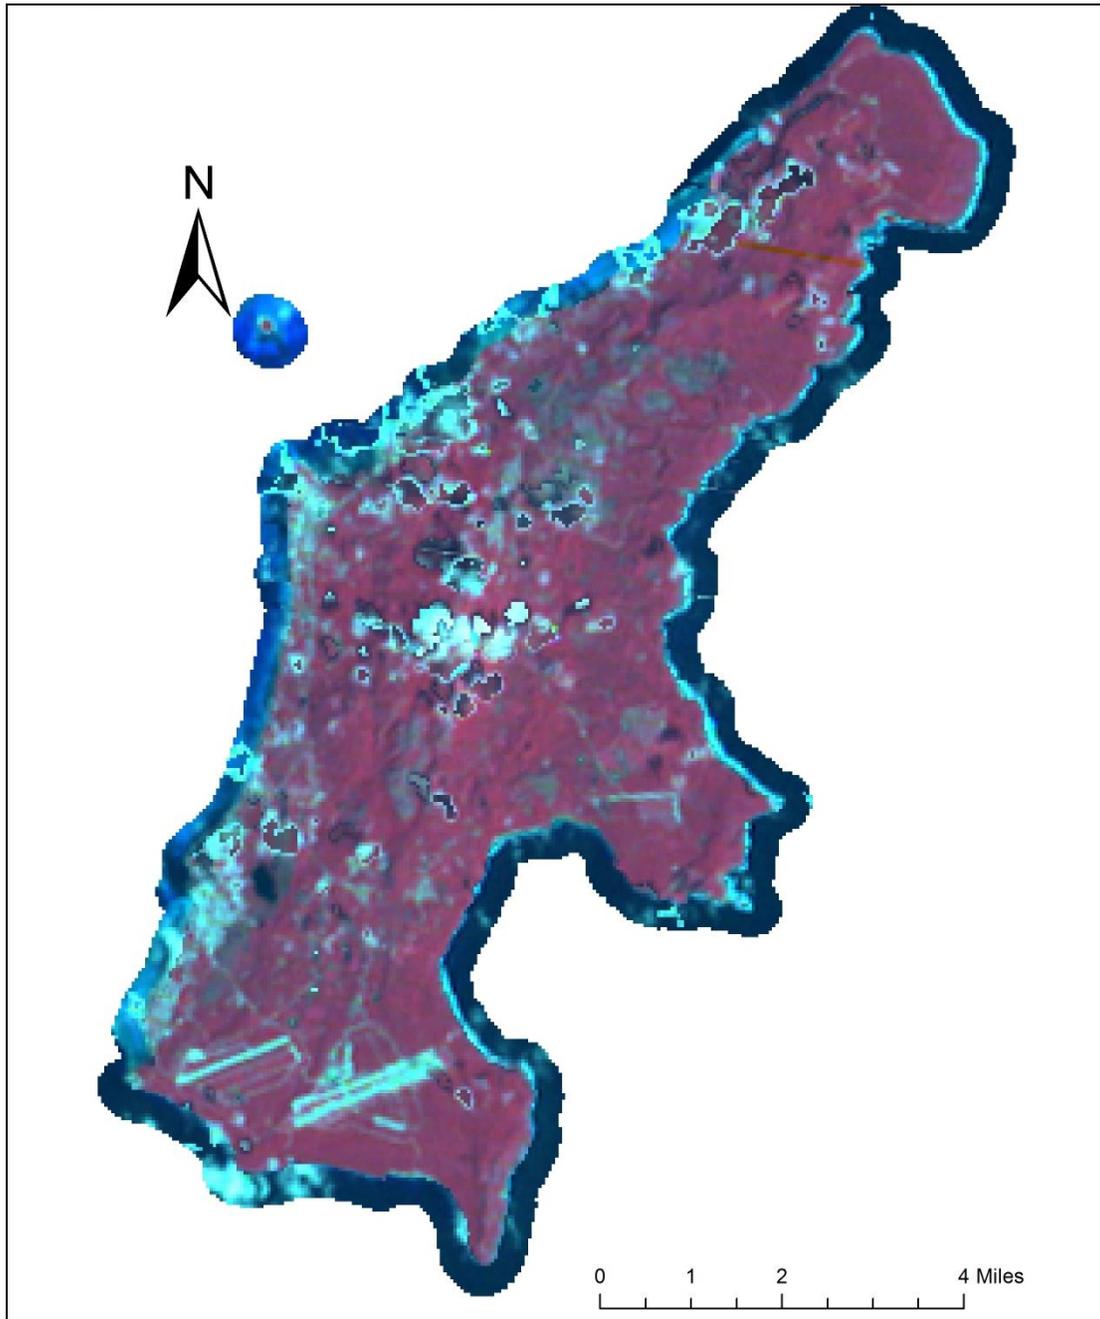
Figure 26. Landsat MSS image of December 10, 1978 was complemented with the Landsat MSS image of October 17, 1978 with clouds and shadows removed

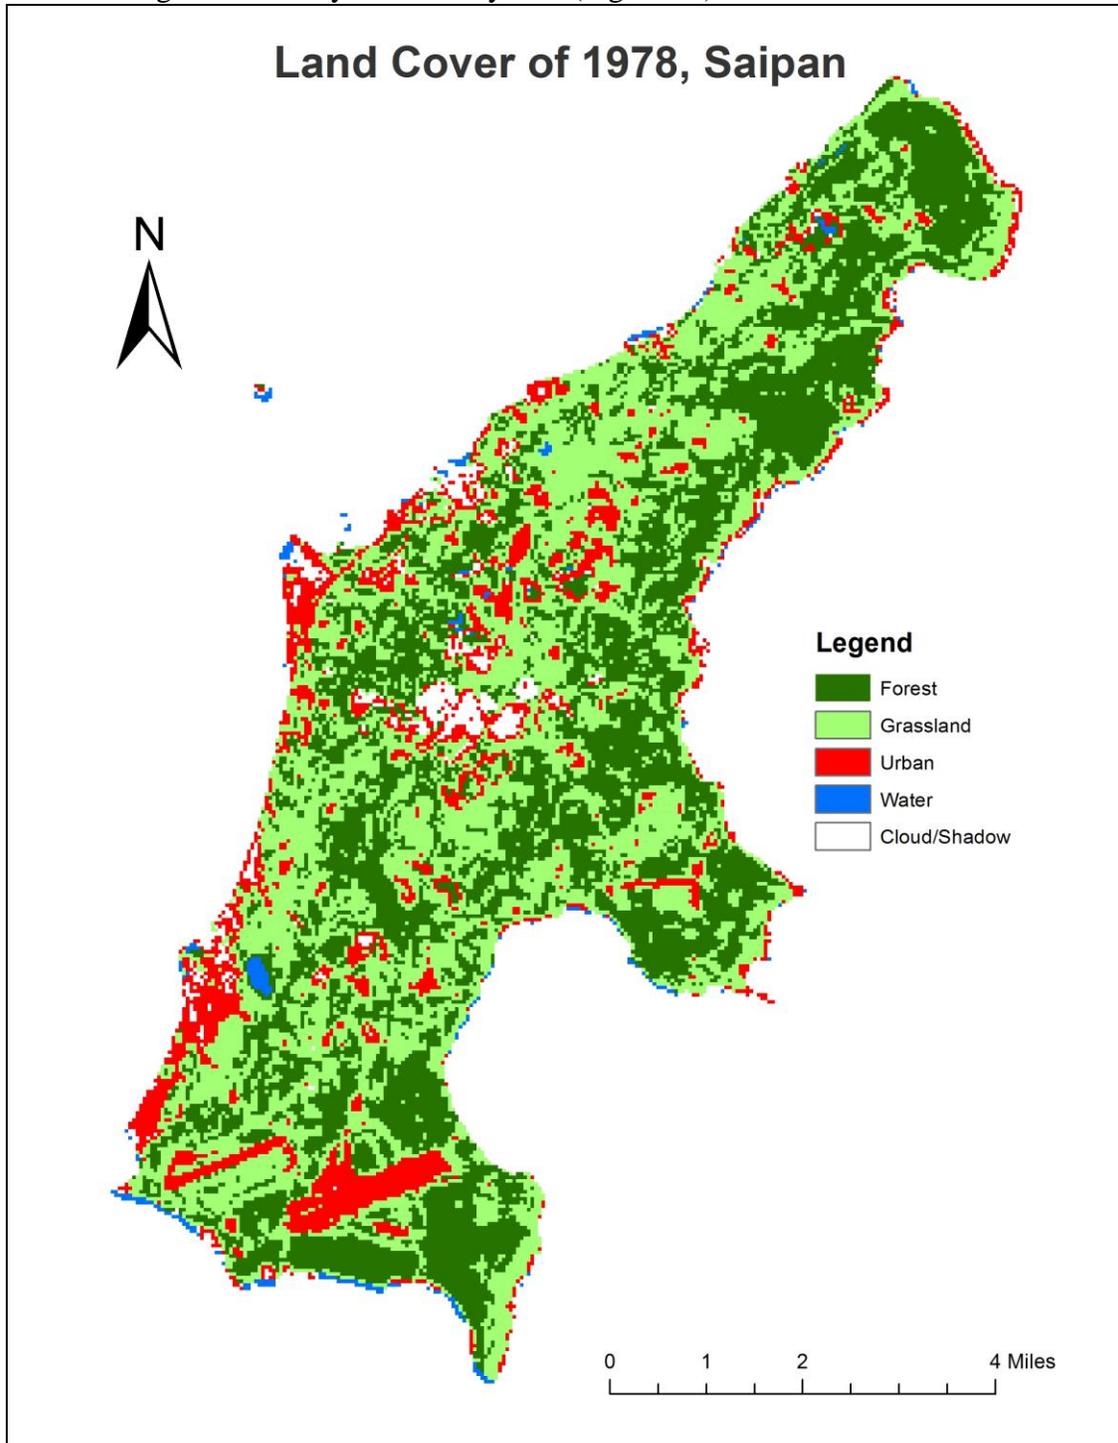
Figure 29. Land Cover Map of 1978

For this research, unsupervised and supervised classification methods were applied to derive land cover information for the available satellite images. It was very time consuming and difficult to extract land cover information from the Landsat MSS image of 1978 because of relatively low data quality, and coarse spatial resolution. This project focused on five general land cover classes, i.e., urban area, forest, water, grassland and cloud. Unsupervised classification method in ERDAS Imagine was employed to generate classes based on features on the Landsat MSS image. Based on the results from unsupervised classification, five general land cover classes were generated based on supervised classification based on the patterns, shapes, textures, tones and colors from the mosaicked Landsat MSS image of 1978. However, there were some errors found from the land cover information obtained from unsupervised and supervised classifications. The airstrip located in Kagman was missing. On-screen digitization in ArcGIS Desktop was used to delineate the airstrip in Kagman. Some parts of Saipan International Airport were misclassified. A subset image was created to cover the area of Saipan International Airport, and developed area in the airport was extracted based on a supervised classification of an unsupervised classification result. Then a further supervised classification was conducted to correct some misclassified classes from the results of unsupervised classification of Landsat MSS image of 1978. Since the land cover information was focused on the buffered study area, the boundary of the study area needed to be used to clip the classified land cover to the extent of the study area. The final land cover information of 1978 is shown in Figure 29.

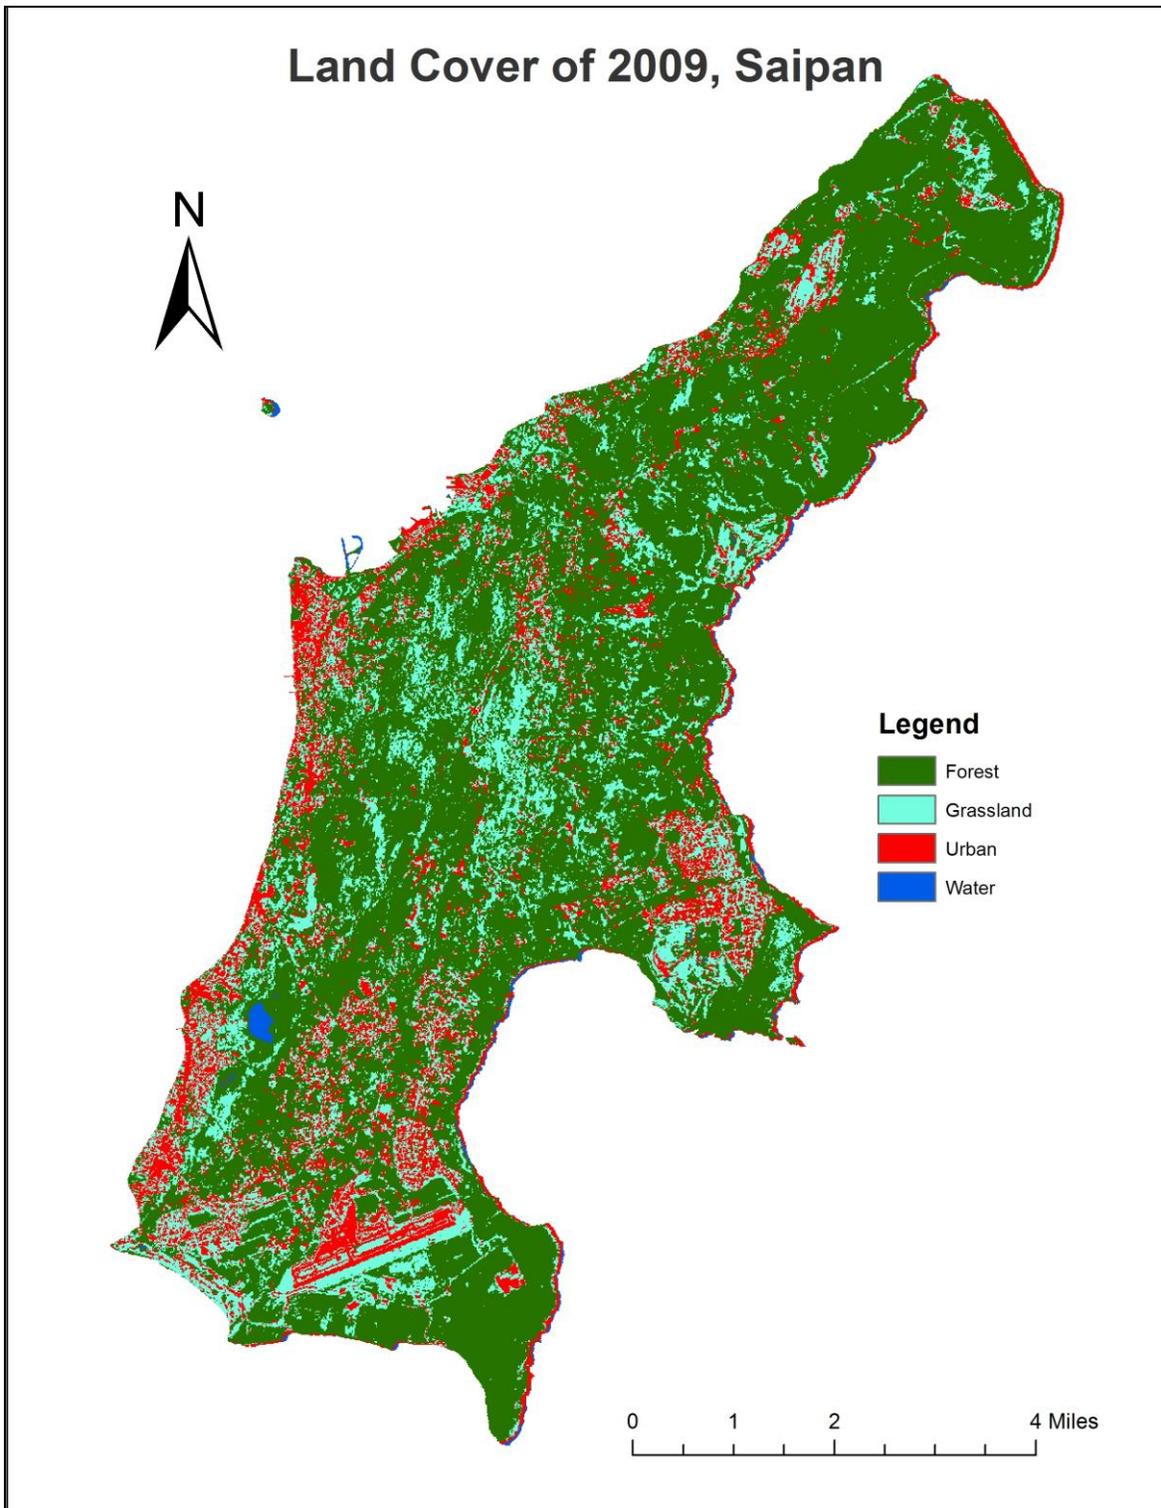
Figure 30. Land Cover Map of 2009

The data quality of ASTER image of 2009 was very good. Five general land cover categories including forest, urban area, grassland, water and badland were used to extract land cover information from ASTER image of 2009. Unsupervised classification method in ERDAS

Imagine was used to derive land cover information from ASTER image of 2009. Then supervised classification was utilized to obtain five general land cover categories of forest, urban area, grassland, water and badland based on patterns, shapes, tones and textures of the image. The final step to achieve the land cover information of 2009 in Saipan was to clip the land cover information using the boundary of the study area (Figure 30).

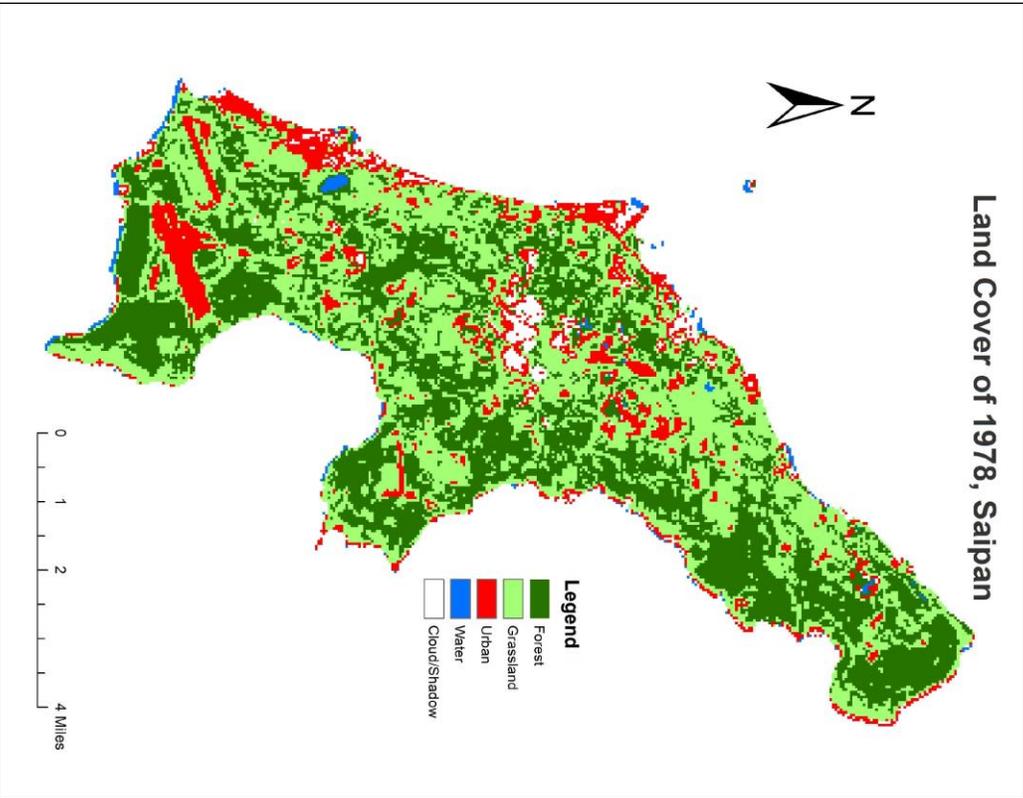
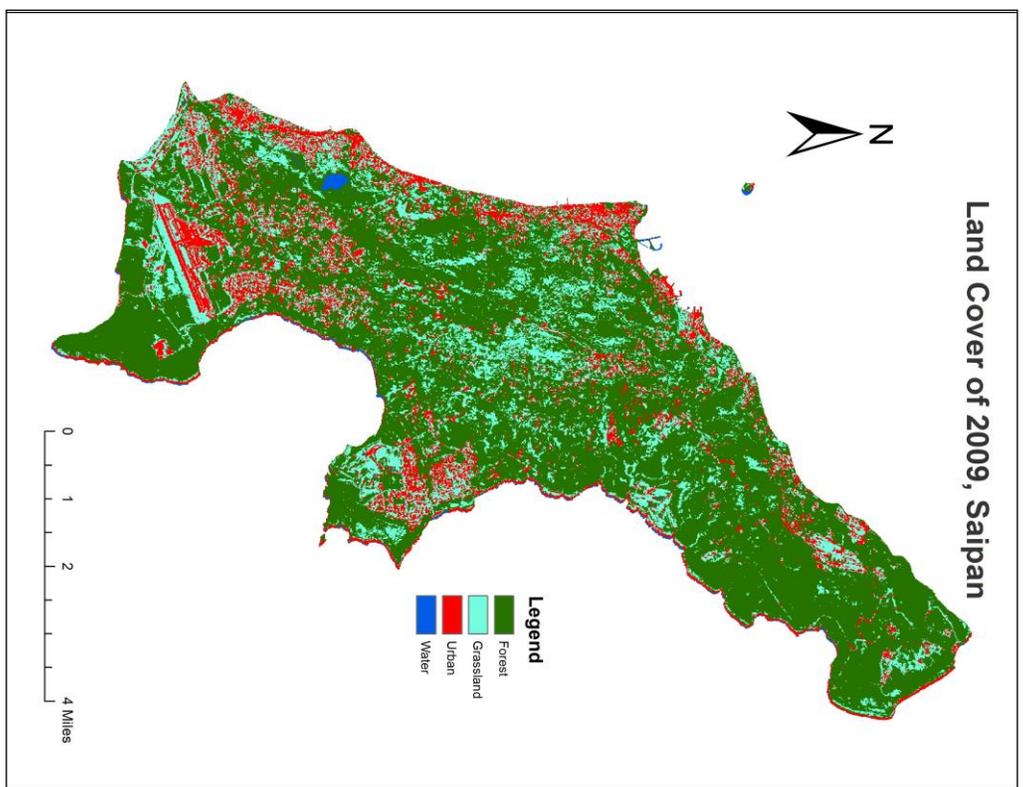
Figure 31. Land cover information of 1978 and 2009

The land cover information of 1978 for Saipan was derived from the Landsat MSS imagery of October 17 and December 10 of 1978. The land cover information of 2009 was derived from the ASTER L1B imagery of March 5 of 2009. Land cover maps of 1978 and 2009 in Saipan are listed in Figure 31 side by side for visual comparison. By comparison of the land cover data between 1978 and 2009, the following conclusions are made (Tables 1 and 2). Saipan was mainly covered by forest and grassland both in 1978 and 2009. The area of forest increased by about 2,923.4 hectares, or 60.88% from 1978 to 2009, and the area of grassland decreased by about 2,672.64 hectares or about 52.1% between 1978 and 2009. The built-up/urban area increased by about 165.6 hectares or 11.6% from 1978 to 2009, and most of the increased urban areas occurred in forest and grassland. Forest change from 1978 to 2009 is shown in Figure 32.

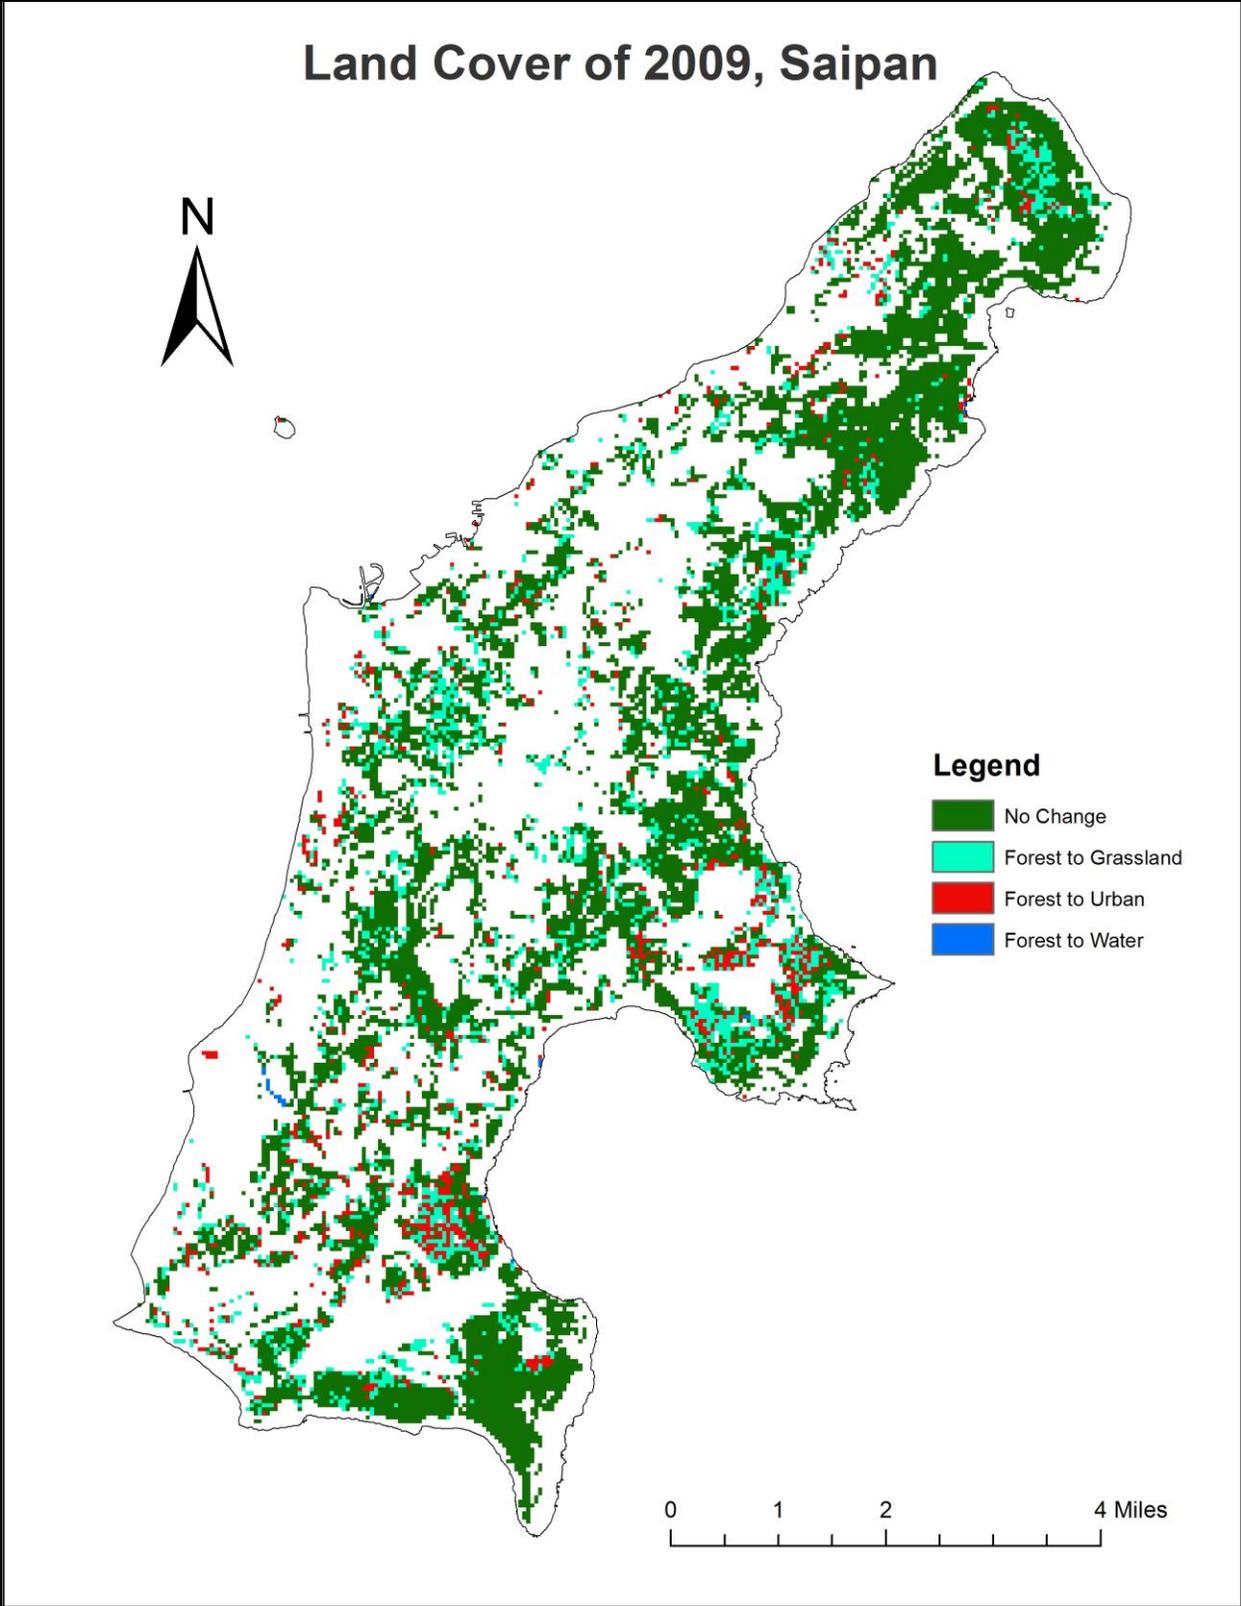
Figure 32. Forest change from 1978 to 2009 in Saipan

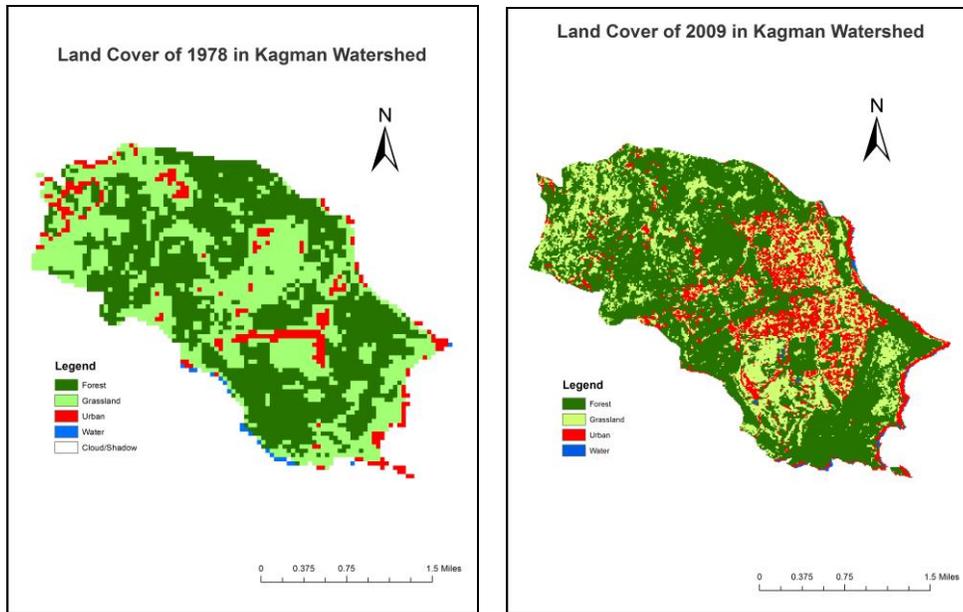
Figure 34. Land cover information of 1978 and 2009 in Kagman Watershed, Saipan

Information about land cover and land cover change in Saipan can be applied to determine land cover change in watersheds in Saipan. There are 11 watersheds in Saipan (Figure 33), and land cover maps of 1978 and 2009 in Kagman Watershed in the Southeastern Saipan are listed in Figure 34. The land cover change information indicated that many development activities occurred from 1978 to 2009 in Kagman Watershed (Tables 3 and 4). The urban area increased by about 106.9 hectares or more than doubles from 1978 to 2009, forest area increased by about 133.2 hectares or about 17.6%, and grassland decreased by about 233.3 hectares or about 38.2%.
