QUALITATIVE EXAMINATION OF GROUNDWATER FROM YAP AND SOME OF ITS NEIGHBORING ISLANDS

Technical Report No. 115

May 2006

Agriculture Experiment Station, College of Micronesia-FSM, Yap Campus
In collaboration with
Yap State Public Service Corporation
&
Yap State Environmental Protection Agency

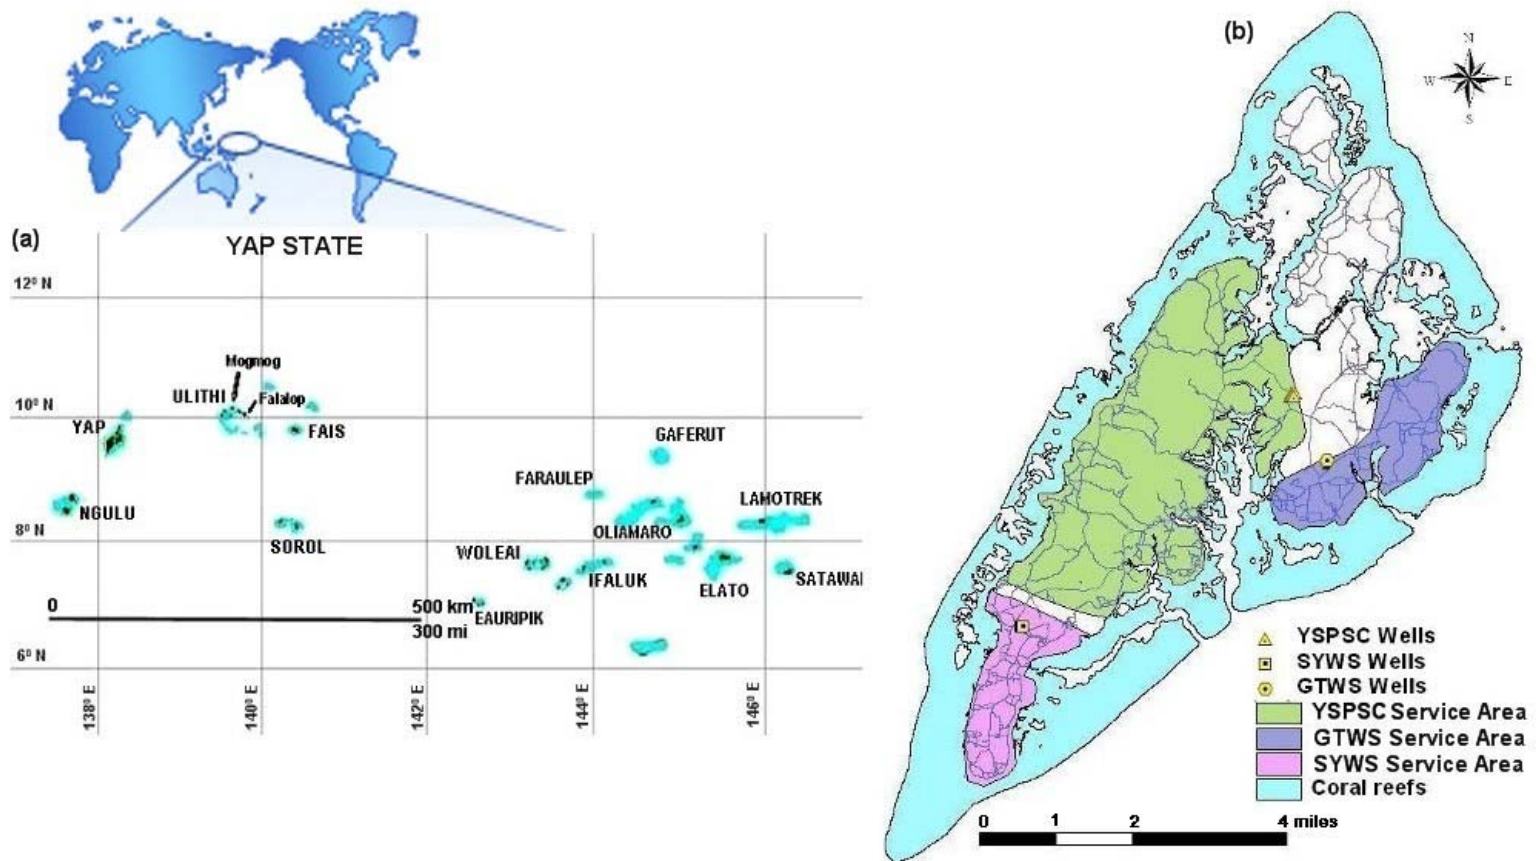
Figure 1 Map showing (a) the location of study site and (b) area of coverage of three large-scale water systems on Yap (also called Yap proper)

This study focused on the three large-scale water supply systems on Yap proper (Figure 1), namely Colonia Water System (YSPSC), Gagil-Tomil Water System (GTWS) and Southern Yap Water System (SYWS), and one lens well at Falalop, Ulithi. While the basic tests, including bacterial tests, have been carried out extensively on samples collected from different localities, detailed analytical tests were conducted primarily on samples collected from five sites – four from Yap proper and one from the neighboring island. Sites were selected based on populations served, the type of source water used, and whether chemical treatments were used. Chemical characteristics and/or contaminants to be tested were selected based on what is commonly found in these types of source waters, as recognized by US EPA.

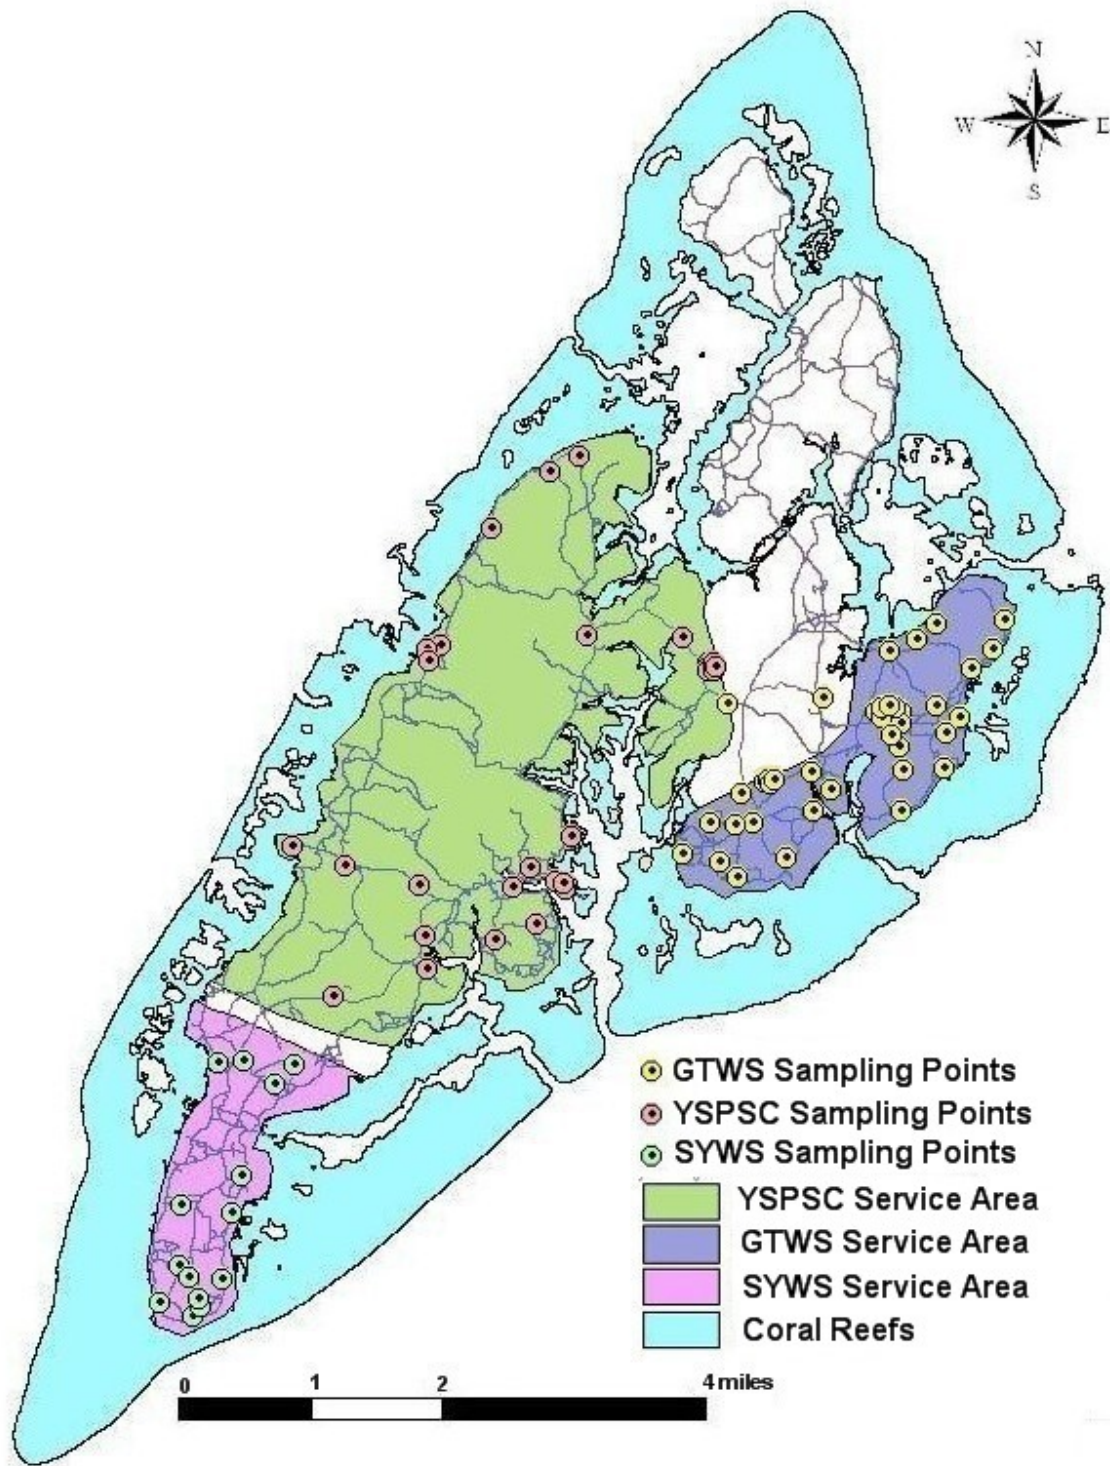
Figure 2 Water sampling locations for bacterial tests on Yap

tests were carried out at many locations. Our test results show a mixed trend in all sampling sites. In all, 179 bacteriological tests were conducted in this study. However, as mentioned earlier, water testing for bacteria is an ongoing program of Yap EPA and continues. In this instance, localities are randomly selected incorporating wells, reservoir, storage tanks, streams and distribution systems.
