HYDROGEOLOGIC INVESTIGATION OF AGANA SWAMP NORTHERN GUAM

Technical Report No. 40

September, 1983

Project Completion Report

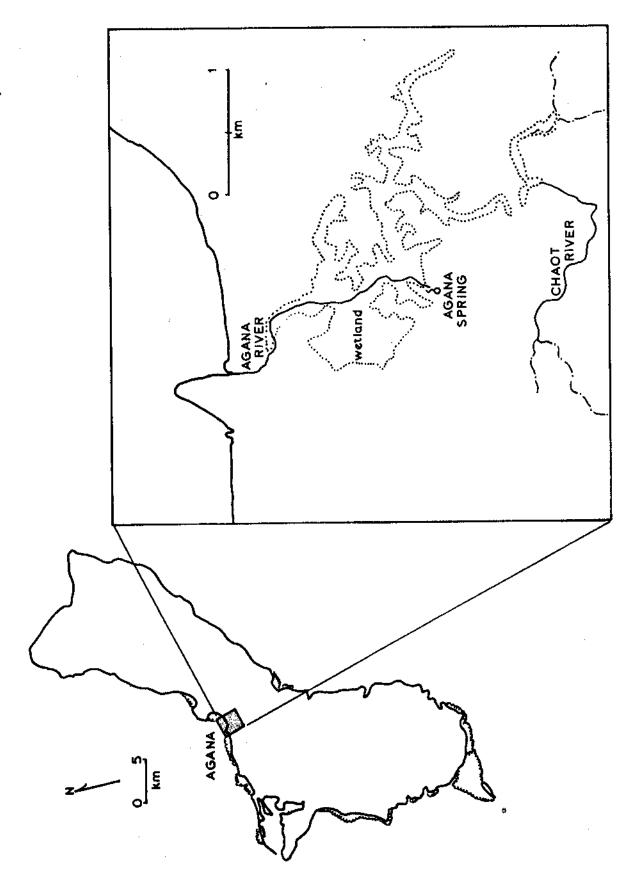
Figure 1. Map of Guam showing the location of the study site.

The study area is located along the west coast of Guam. Agana Swamp is situated within the southern region of the limestone plateau that dominates the physiography of the northern half of the island. The map of Figure 1 shows the location of the study area relative to other prominant features of Guam.

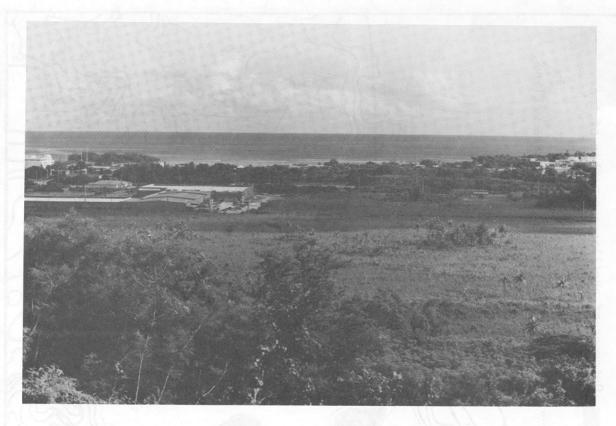
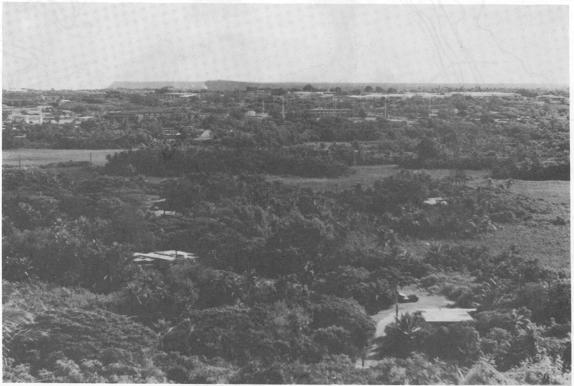
Figure 3. Overview of the study area. Top photograph shows the western portion and the bottom photograph shows the eastern portion of Agana Swamp.

Agana Swamp occupies the low lands of the Agana-Choat river basin and consists of a broad belt of marshy and swampy area that trends northwest to southeast. The swamp area attains a maximum width toward the northwest end between the villages of Sinajana and Mongmong. Bordering the study area are low limestone ridges (20 to 40 feet in altitude) that project into the generally flat floor of Agana Swamp. Limestone crops out within the swamp as isolated hills and hummocks. The map of Figure 2 and the photographs of Figures 3 and 4 show the general physiographic features present within the study area.

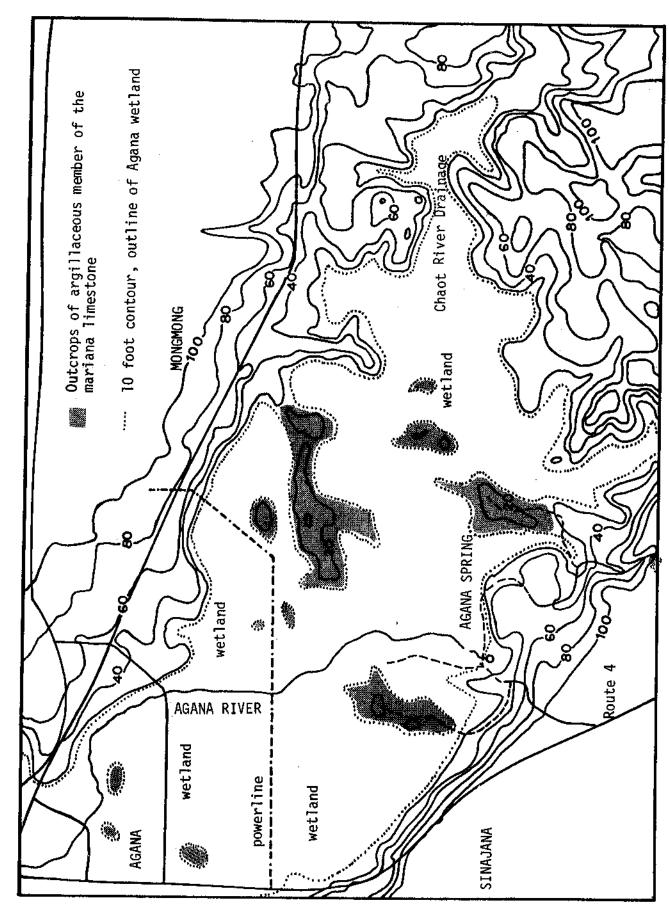
Map of the study area showing prominant physiographic features. Figure 2.

Located at the base of a hill along the southern perimeter of the swamp is Agana Spring (Figure 2). Water discharges from the Agana argillaceous member of the Mariana limestone (Tracey et al., 1964) and collects in a concrete reservoir. The spring outflow is situated a few feet above the general level of the swamp area.

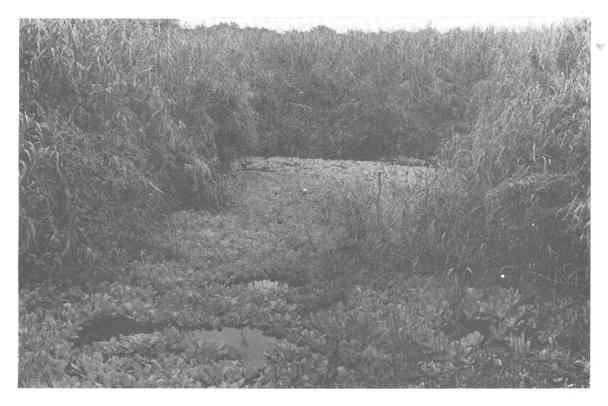
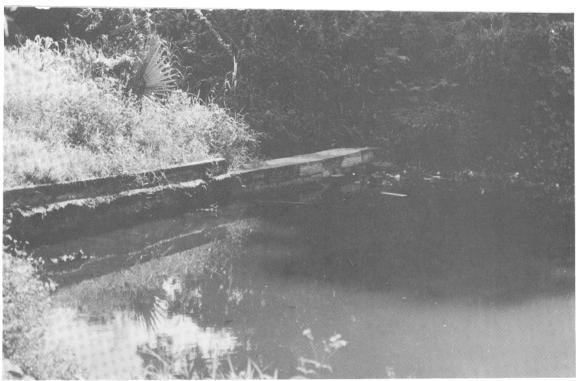
Figure 4. View of a portion of Agana River and Agana Spring. Top photograph shows the vegetation-choked river channel and the bottom photograph shows the reservoir at Agana Spring.

The study area is drained primarily by the Agana River; however its course is not well defined except near the outflow where the channel has been maintained through East Agana. Elsewhere, siltation and vegetation have nearly obliterated the course of the river. What remains is a shallow depression which leads to Agana Spring and probably represents the river channel before infilling and overgrowth.

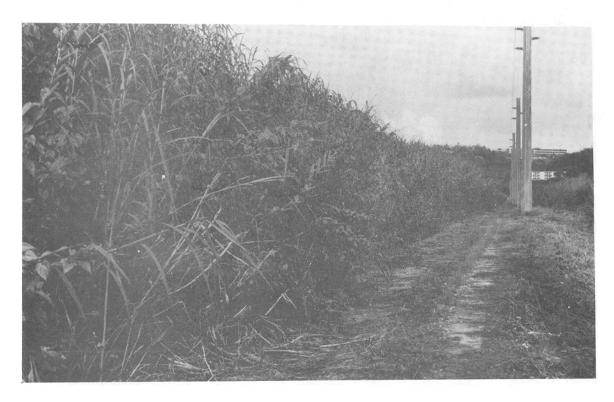
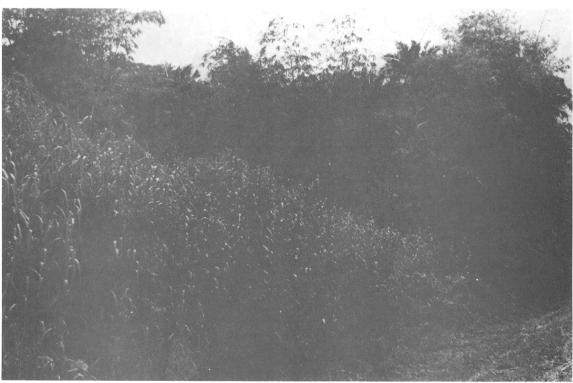
Figure 5. Views of the predominant swamp vegetation, $\frac{\text{Phragmites}}{\text{along the power-line easement.}}$

Vegetation within Agana Swamp is predominately a tall reed, <u>Phragmites karka</u> (Figure 5), with lesser occurrences of other herbaceous woody trees, and shrub types. The latter are primarily associated with the border area and limestone hummocks.

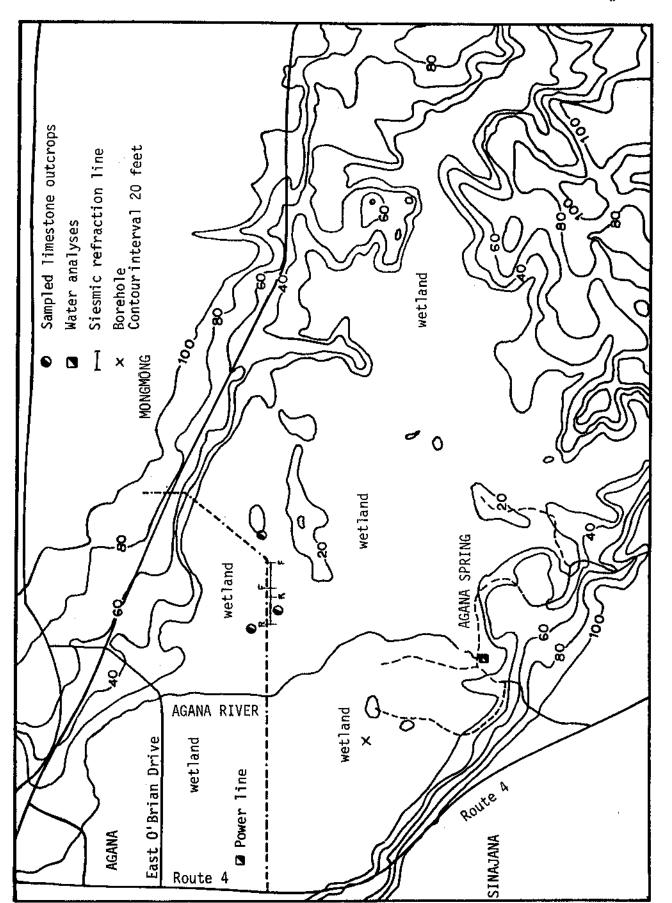
Map of the study area showing the location of seismic-refraction lines and sampling sites. Figure 6.

Bedrock seismic velocities obtained from lines 1 and 2 are 4149 ft/sec and 5752 ft/sec respectively (see Figure 6 for locations and Appendix for details). These values, although low for limestone, probably reflect the lithology and secondary features (particularly clay-filled solution cavities) of the Agana argillaceous member. Similar to slightly higher velocities were measured by Biehler and Walen (1981) for pure limestones (layer 2) of the northern plateau.

According to boreholes installed within the swamp area (Randall and Tsuda, 1974), the bedrock is overlain by unconsolidated marine sediments and organic material. The borehole log below summarizes the stratigraphy overlying the bedrock (Randall and Tsuda, 1974; p 12-13; see Figure 6 for borehole location):

Limited water quality data for Agana Swamp are listed in Table 1. The data are from Smith and Hedlund (1978) and were obtained from the analysis of samples collected near O'Brian Street (Figure 6). As indicated by the data, the near surface water is low in chloride, nitrate, nitrite, and orthophosphate and, in general, is low in total dissolved solids (low specific conductance). As might be expected, turbidity and suspended material are relatively high since the samples were taken in a near surface environment and not from specially constructed groundwater sampling facilities. The pH measurements indicate a water near neutrality; however, the range of values appears to take in slightly acidic water. This no doubt is due to the high level of organic activity which influences the near surface environment.

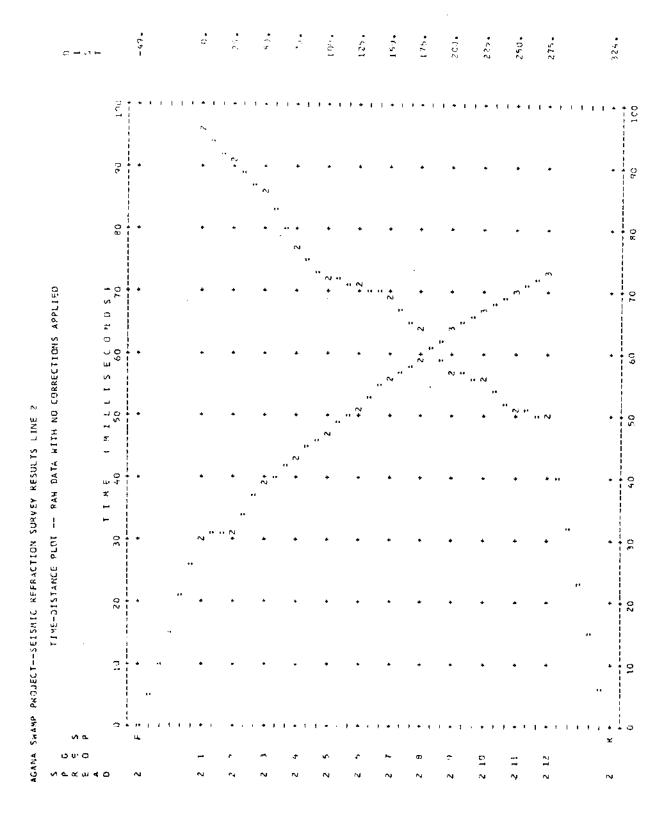
SMOOTHED POSITION OF LAYERS BENEATH SHOTPOINTS AND GEOPHONES AGANA SWAMP PROJECT--SEISMIC REFRACTION SURVEY RESULTS LINE 1 SPREAD 1

IONES AGANA SWAMP PROJECT--SEISMIC REFRACTION SURVEY RESULTS LINE 2

Seismic refraction work also revealed a higher velocity layer beneath that indicated above. From the analyses of lines 1 and 2, the higher velocities were 9332 ft/sec and 6728 ft/sec respectively. These higher values may indicate either a denser argillaceous unit of the Agana member, a change in facies, or a different geologic unit altogether.
