SOLAR PUMPING FOR VILLAGE WATER SUPPLY SYSTEMS ON TRUK

Technical Report No. 49

Partial Project Completion Report
for
Truk State Government
Federated States of Micronesia

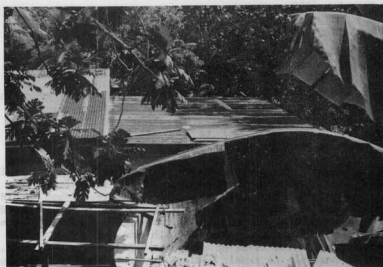
Figure 1. Solar modules mounted on roof of residence in Kuchua Village.

Three 28 watt Solar Power Corporation solar modules were connected in parallel to drive a Rule 800 submersible bilge pump. The modules are located on the top of the residence (Figure 1) and a switch is provided for actuating the system. One half inch PVC pipe connects the pump, situated approximately 6 inches from the bottom of the lower tank, to the upper tank (Figure 2). The total length of pipe is approximately 15 feet.

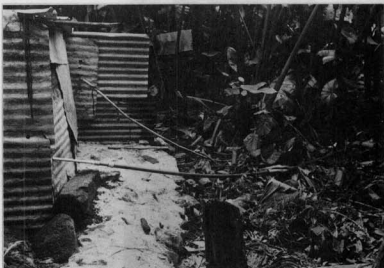
Figure 4. Pipe leaving pump enclosure and entering taro patch near Epinup Village.

Three 28 watt Solar Power Corporation solar modules were connected in parallel to drive a Shurflo Series 200 diaphragm pump. Four hundred fifty feet of 3/4 inch and 20 feet of 1/2 inch PVC pipe were added to the existing 300 to 400 feet of 3/4 inch and 1-1/2 inch galvanized and plastic pipe. The pipe is routed through a taro and mangrove area to the center of the village, temporarily discharging into a 55 gallon drum (Figures 4, 5, and 6). The pump is installed within the enclosure over the well (Figure 7). Because of fear of vandalism, the solar modules are not permanently mounted in the open. Rather, they are stored in the well enclosure (Figure 7) and placed on the roof of the enclosure when pumping is desired (Figure 8).

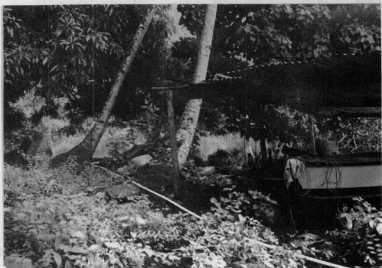
Figure 5. Piping from pump to Epinup Village.

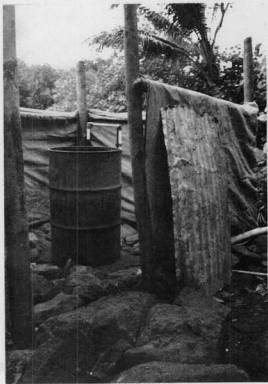
Figure 6. Temporary discharge point of pipe in Epinup Village. (photo on left)

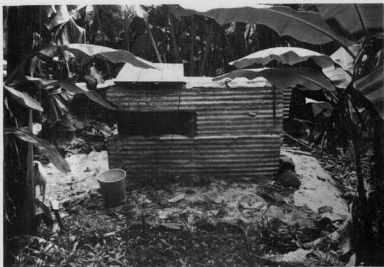
Figure 8. Solar modules temporarily mounted on pump enclosure near Epinup Village.

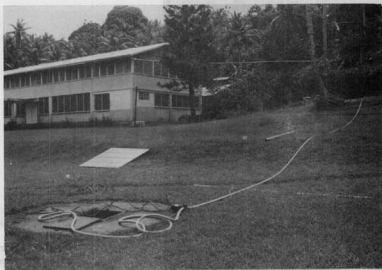
Figure 9. Setup for test of solar pumping system at Liebensel School in Chukianeu Village.

The system was tested (Figure 9) with a water depth of 6 feet in the well. The measured flow rate was 2.4 gpm, significantly higher than the 1.75 gpm anticipated. In order to simulate a low water level situation, the diaphragm pump was elevated approximately 6 feet above the ground surface (however, this does not increase the total lift from water level to discharge point). No change in pumping rate was observed.
